Cook Shire Council

Webber Esplanade

Rock Revetment Review

April 2016

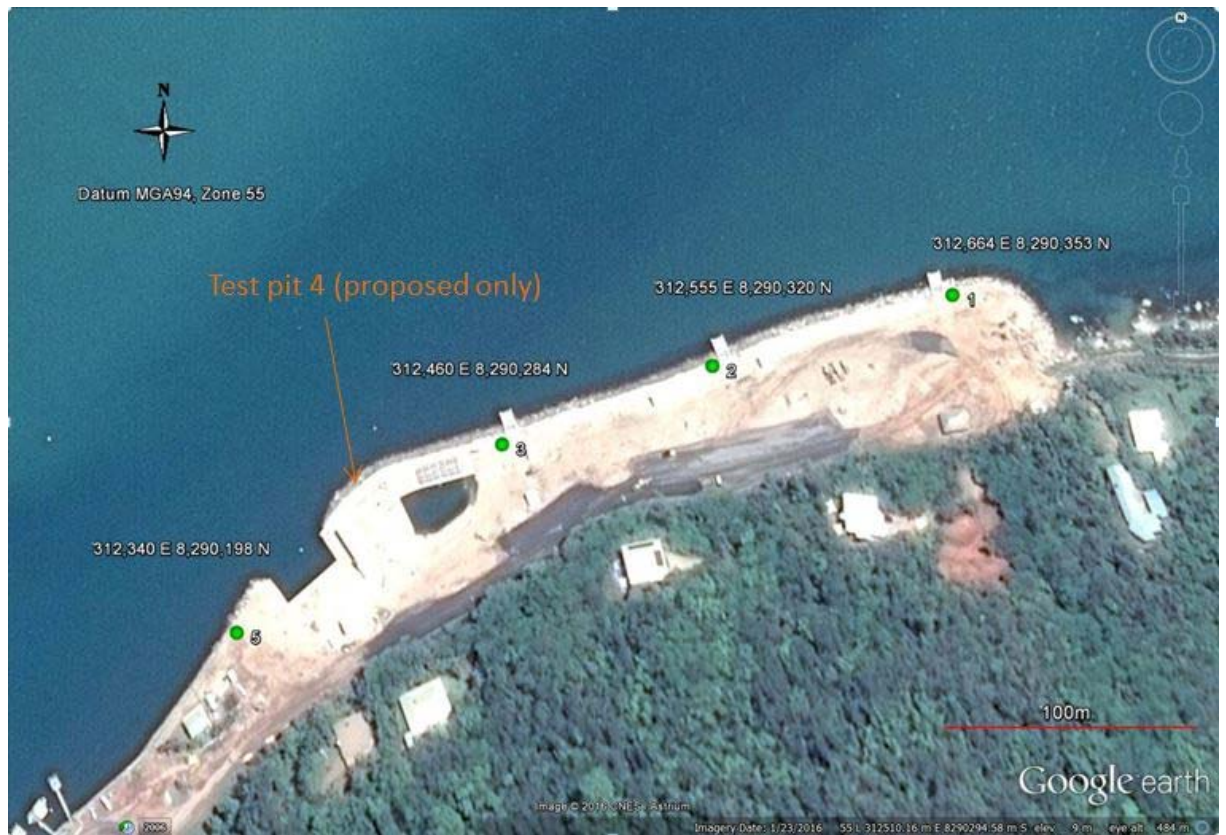
Figure 1 'Peel back' locations

A total of four (4) 'peel backs' were undertaken along the revetment extent, numbered 1, 2, 3, and 5 as shown below in Figure 1. 'Peel back' number 4 was not completed due to the constraints of existing built infrastructure. On the basis of generally consistent results observed at the 4 locations where "peel backs" were undertaken (1, 2, 3 and 5), it was concluded on site that 'peel back' number 4 would provide little value for the high costs to complete.

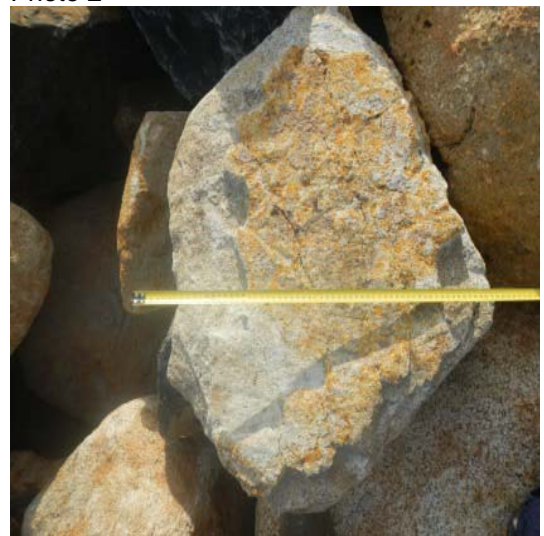
Photo 4

2.	<p>Armour rock on the slope has a wide grading, generally ranging from 30 mm (D_{min}) to 1500 mm (D_{max}). See photos 4 to 7, 11 to 14 and 21 to 28 below, in particular.</p>	No	No, under sized armour rock non-compliant with design storm event criteria

3.	<p>Armour porosity too high with poor interlocking evident. Some armour rock is unstable under foot. It appears likely that rock was end dumped from truck tipper as opposed to being selectively placed by excavator in 2 layers. See photos 2 and 17, below in particular.</p>	Strictly not specified	No, under sized armour rock non-compliant with design storm event criteria

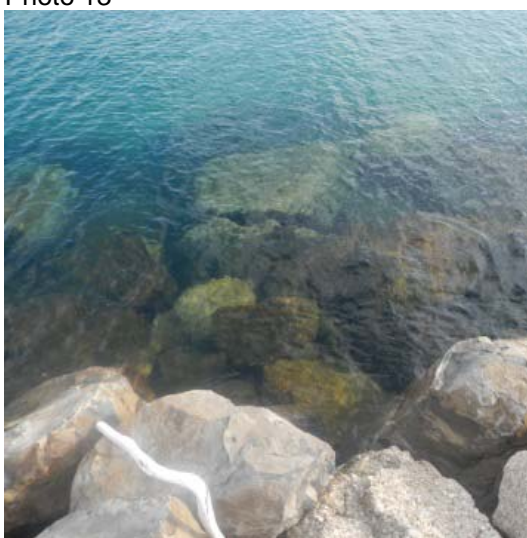
Photo 15

1.	<p>Toe rock has been placed on the seabed, generally 2 to 3 rocks in length, and sized generally in accordance with the amended approved drawing CSC-C002 rev 0. See photo 15 below, in particular.</p> <p>The toe rock generally exceeds the specified D_{n50} 900 mm, typically ranging from 1 to 2 metres in diameter.</p>	Yes, based on an assumed rock density of 2.6 t/m^3	Yes, toe rock provides allowance for scour.

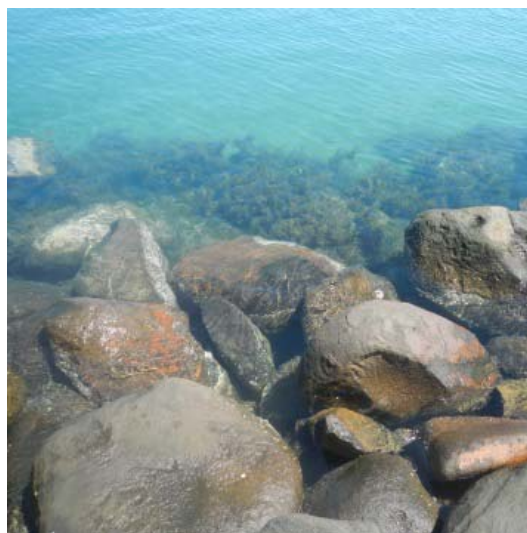
Photo 36

1.	<p>Toe rock has been placed, generally 2 to 3 rocks in length, and sized generally in accordance with the amended approved drawing CSC-C002 rev 0. See photos 36 and 37 below.</p> <p>The toe rock generally exceeds the specified D_{n50} 900 mm, typically ranging from 1 to 2 metres in diameter.</p>	Yes, based on an assumed rock density of 2.6 t/m ³	Yes, toe rock provides allowance for scour.

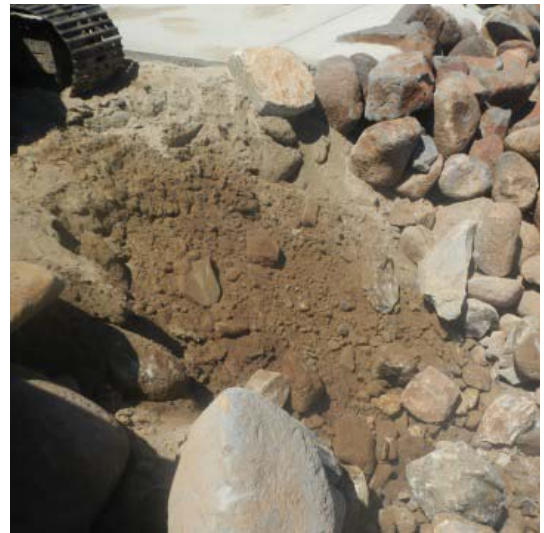
Photo 48

2.	<p>Armour rock on the slope has a wide grading, generally ranging from 30 mm (D_{min}) to 2000 mm (D_{max}). Two distinct layers of rock armour not placed. See photos 47 to 50 below, in particular.</p>	No	No, under sized armour rock non-compliant with design storm event criteria

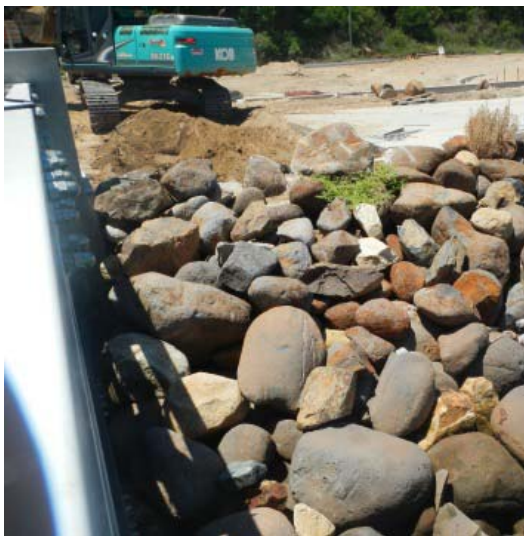
Photo 60

2.	Armour rock on the slope has a wide grading, generally ranging from 30 mm (D_{min}) to 1500 mm (D_{max}). See photo 60 in particular.	No	No, under sized armour rock non-compliant with design storm event criteria

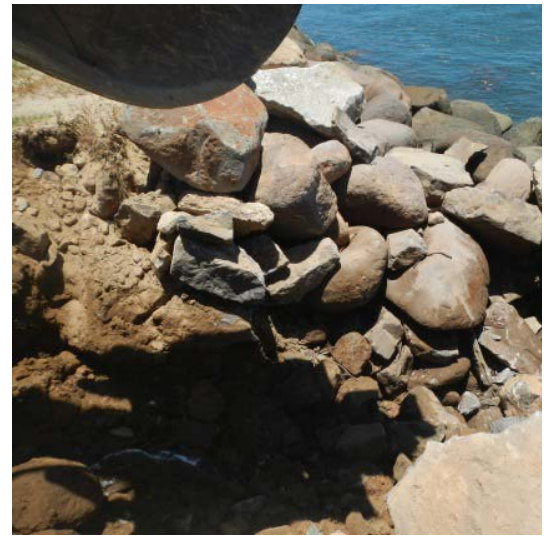
Photo 71

2.	Armour rock on the slope has a wide grading, generally ranging from 30 mm (D_{min}) to 2000 mm (D_{max}). See photo 71 below.	No	No, under sized armour rock non-compliant with design storm event criteria

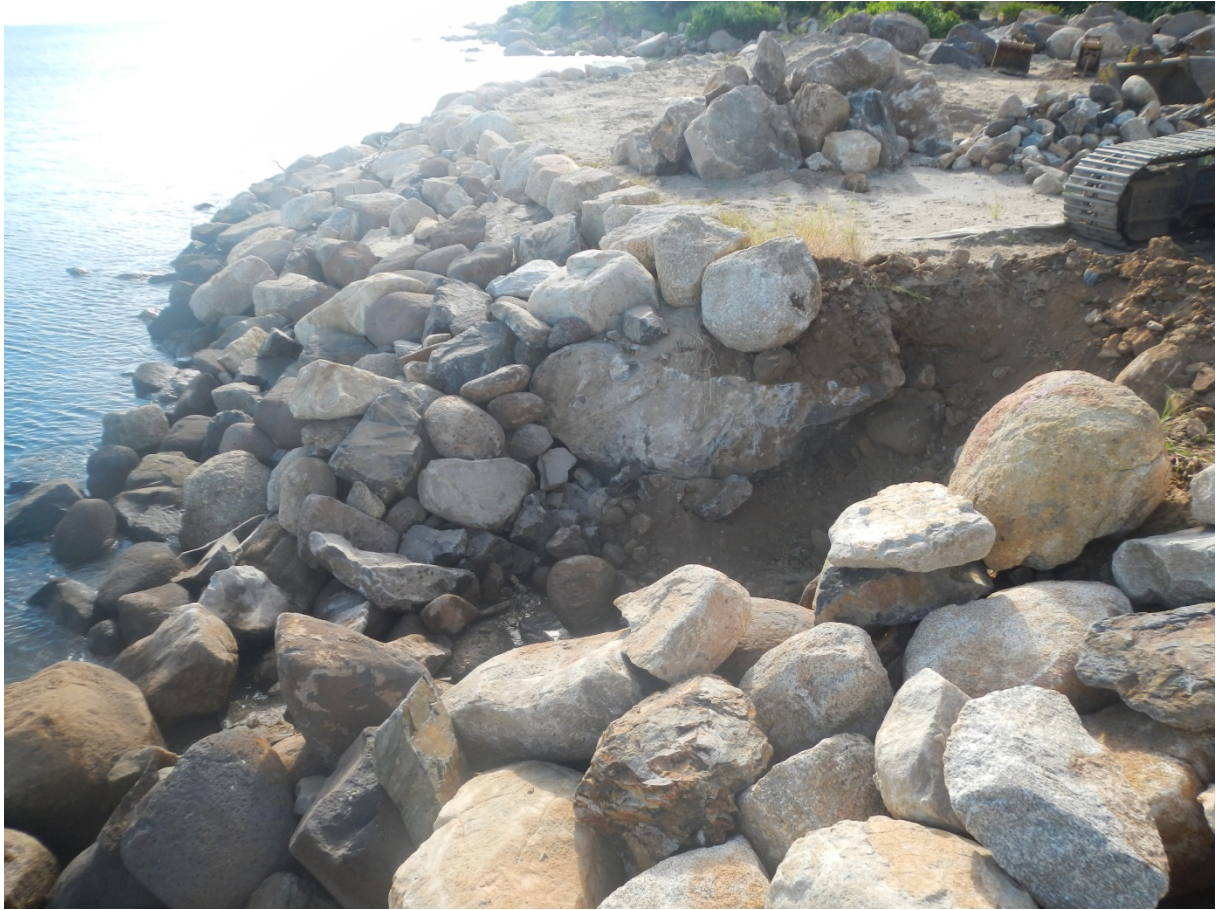
Figure 2 Armour rock and test pit 1 interface

In addition to the rock shown above, an additional 'blue rock' sample was taken. It was noted on site that a small fraction of armour consisted of angular 'blue rock', typically borne from quarry blast production, as shown typically in Figure 2. Note the large 'blue' armour rock at the crest adjacent along the bounds of the 'peel back' excavation.
