| Subject | 'As-Constructed' Rock Revetment | Job no. | [REDACTED] |

The Webber Esplanade rock revetment located within Cooktown and previously designed by GHD, received tidal works approval in late 2005 / early 2006. The GHD design drawings have been provided for ease of reference in Appendix A. The wall was subsequently constructed under the supervision of the Cook Shire Council and it is our understanding that there were a number of variations to the design. A typical 'as-constructed' cross section sketch was provided by Cook Shire Council (see Appendix B).

COOK SHIRE COUNCIL
WEBBER ESPLANADE - COOKTOWN
REVTMENT WALL - AS BUILT
DESIGN CHECK - SECTIONS SH1

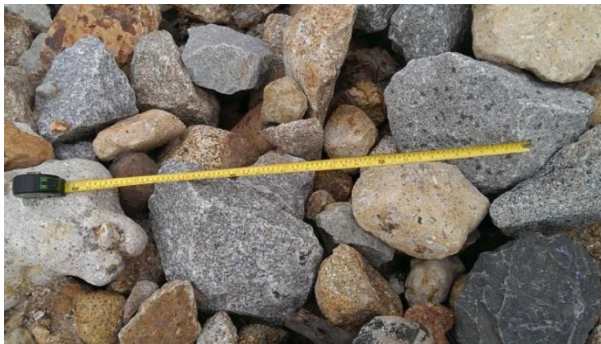
Photo 1 – Core material

- d. Geotextile layer was not placed beneath the filter layer, according to the sketch provided in Appendix B.
- e. It is our understanding that core material of '100-300 mm clean rock' was placed with the intent of negating the need for a geotextile layer beneath the filter rock as shown in photos 1 to 3 below. It has been confirmed by Cook Shire Council that the core material was placed within the entire length of the structure.

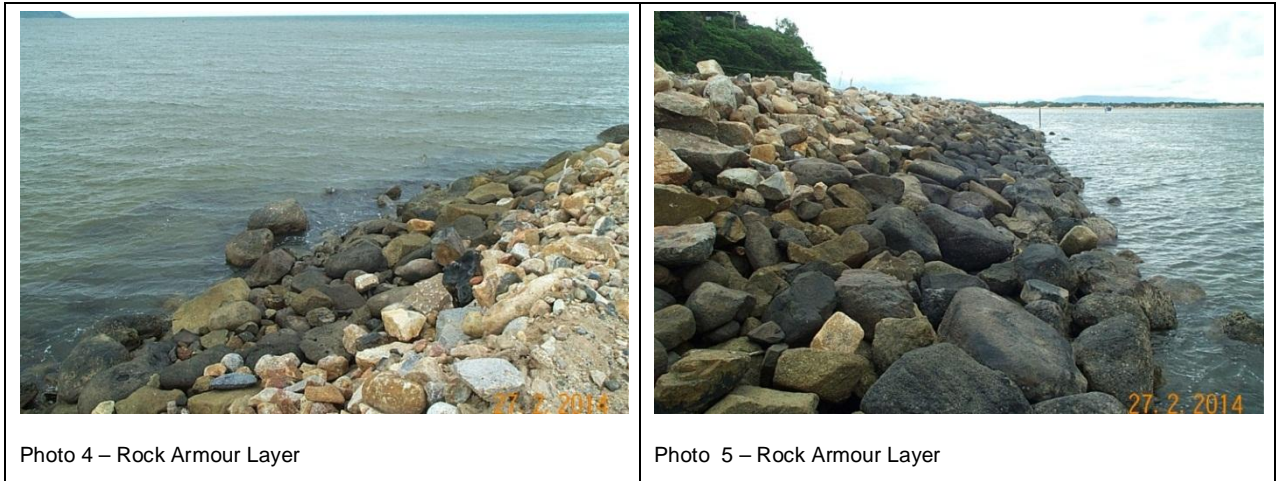
Received photos of the rock armour are shown below in photos 4 and 5.

- Photos 4 and 5 seem to show that the grading of the rock armour seems wider than expected. There appears to be small rock mixed in with the large rock armour, particularly at the crest. This is an interpretation based on the supply of photos and no visual inspection has taken place to confirm this assessment.
- It is expected that during the design storm event, the steeper slope along the rock armour layer will likely suffer greater damage (greater than 5%). Consequently this may lead to higher maintenance costs for Cook Shire Council and an increased risk of filter rock exposure.
- To achieve rock armour stability in line with the original design, the equivalent significant wave height reduces approximately 45% to 1.55 m for those areas where the slope is steeper than the original design slope of 1 vertical to 2 horizontal.

- Photos taken during construction and QA site records, if available, should be provided in order to confirm the assumptions made during the assessment.
- It is recommended that the seaward face of the revetment be topped up with rock armour to achieve a 1 in 2 slope uniformly along the full length of the revetment.
- Raising the crest finish level with rock armour to +4.98 m LAT is recommended in order to ensure overtopping volumes are within the guidance values provided by CIRIA.
- In the process of raising the crest, the existing small graded rock as shown in photo 4 and 5 should be removed and replaced with rock armour.
- Install the 1200R Elcomax geotextile as per the recommendations provided above.

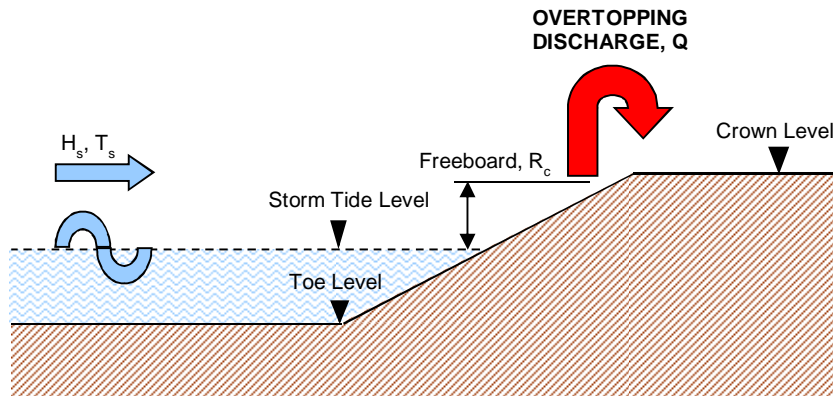
Figure 1: Overtopping Discharge

Wave overtopping (see Figure 1) calculations have been completed in accordance with Owen's (1980) method.

The revetment wall has been designed for an overtopping discharge of 135 litres per second per metre length of wall.

In order to meet this overtopping criterion, the rock revetment crest level would need to be uniformly raised along the structure to +3.5 m AHD or +4.98 m LAT. The 'as-constructed' survey shows that currently the crest level varies from +1.78 m LAT to approximately +4.0 m LAT. Overtopping discharge per metre length of wall during the design event is expected to exceed 300 litres per second for the current 'as-constructed' crest.

Plans for the works behind the revetment wall have not been provided, hence the effects of the increased overtopping volumes cannot be evaluated. However, one of the keys to mitigating the effects of overtopping is to provide adequate drainage capacity to safely channel the water away from the landward side of the wall. Therefore, careful consideration of the drainage infrastructure required is recommended in order to ensure the integrity of the rock revetment during the design storm event.

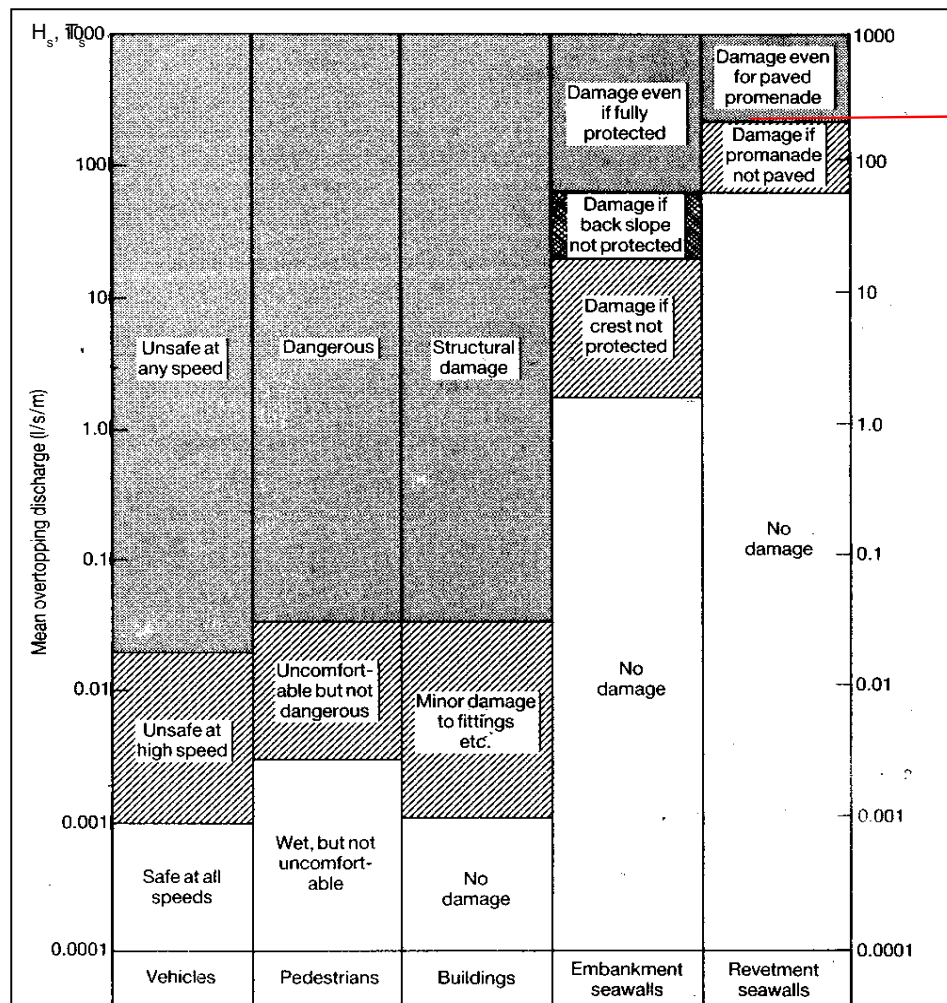
Figure 2: CIRIA/CUR (1991), Manual on the use of rock in coastal and shoreline engineering, CIRIA Special Publication 83/CUR Report 154, pg. 253-257.

Guidance by CIRIA on allowable critical discharge is provided below in Figure 2. It should be noted that this gives allowable mean overtopping discharge, which may actually be exceeded by maximum overtopping discharge during the design storm event. Figure 2 shows that assuming the area immediately behind the revetment wall is paved/sealed, as a minimum, an overtopping volume of 300 litres / second / metre of wall would be considered acceptable.

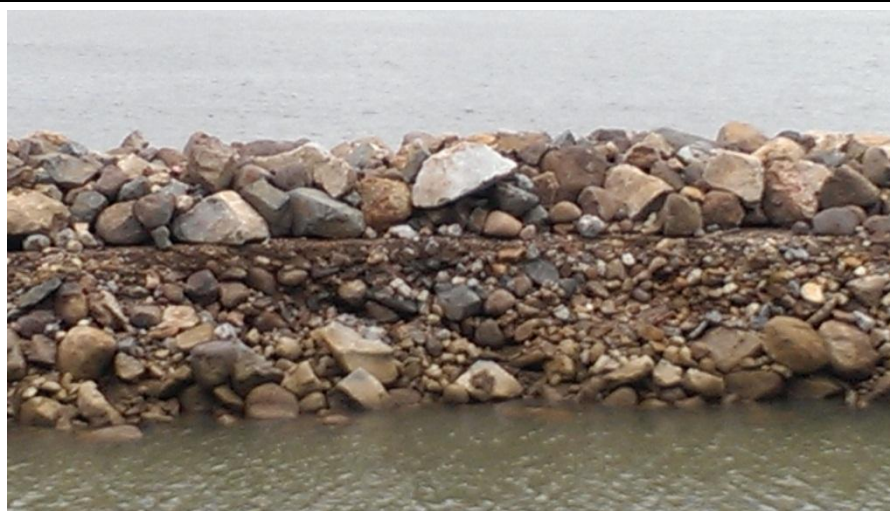
Photo 6 – Revetment Back Face

- Based on the photo 6 below, it is evident that there is some large rock on the revetment slope back face. Due to the risk of elongation and even tearing of the geotextile on application of spoil load, adoption of one of the following options is recommended;

- The back face is re-worked to remove the large rock, thereby leaving a 'smooth' slope with rock of uniform grading.
 - Place a uniform graded rock (Dn50 = 50 mm), up to an appropriate thickness to achieve a 'smooth' slope.

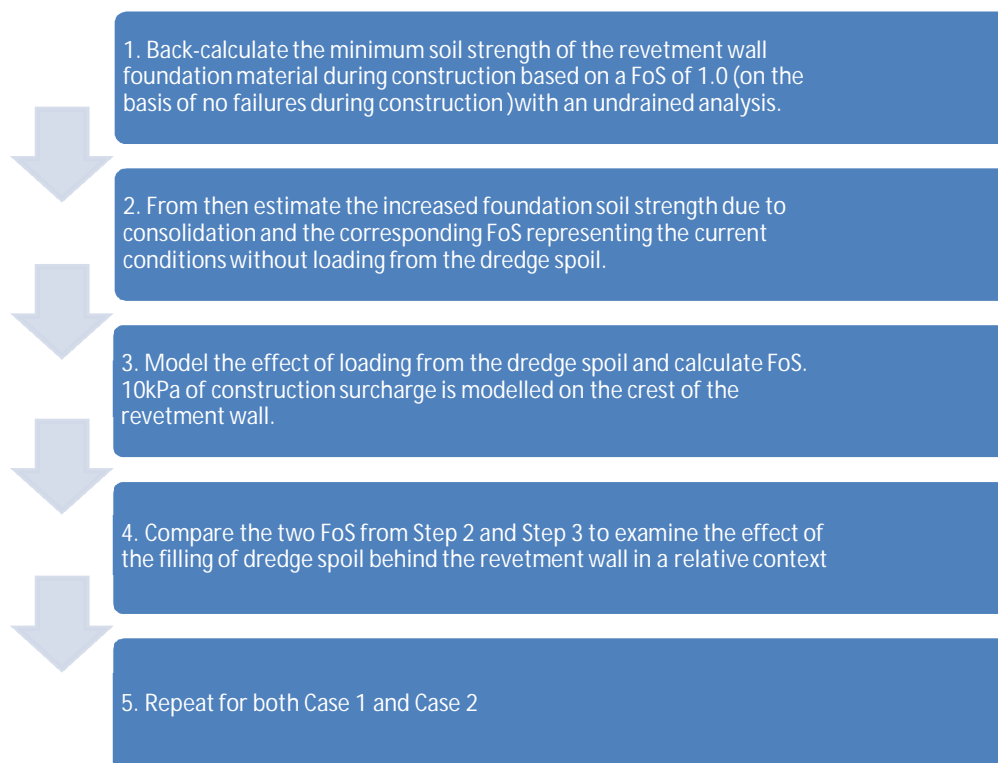
Figure 3 Methodology of geotechnical assessment

The methodology of analysis is best illustrated by the flow chart in Figure 3.

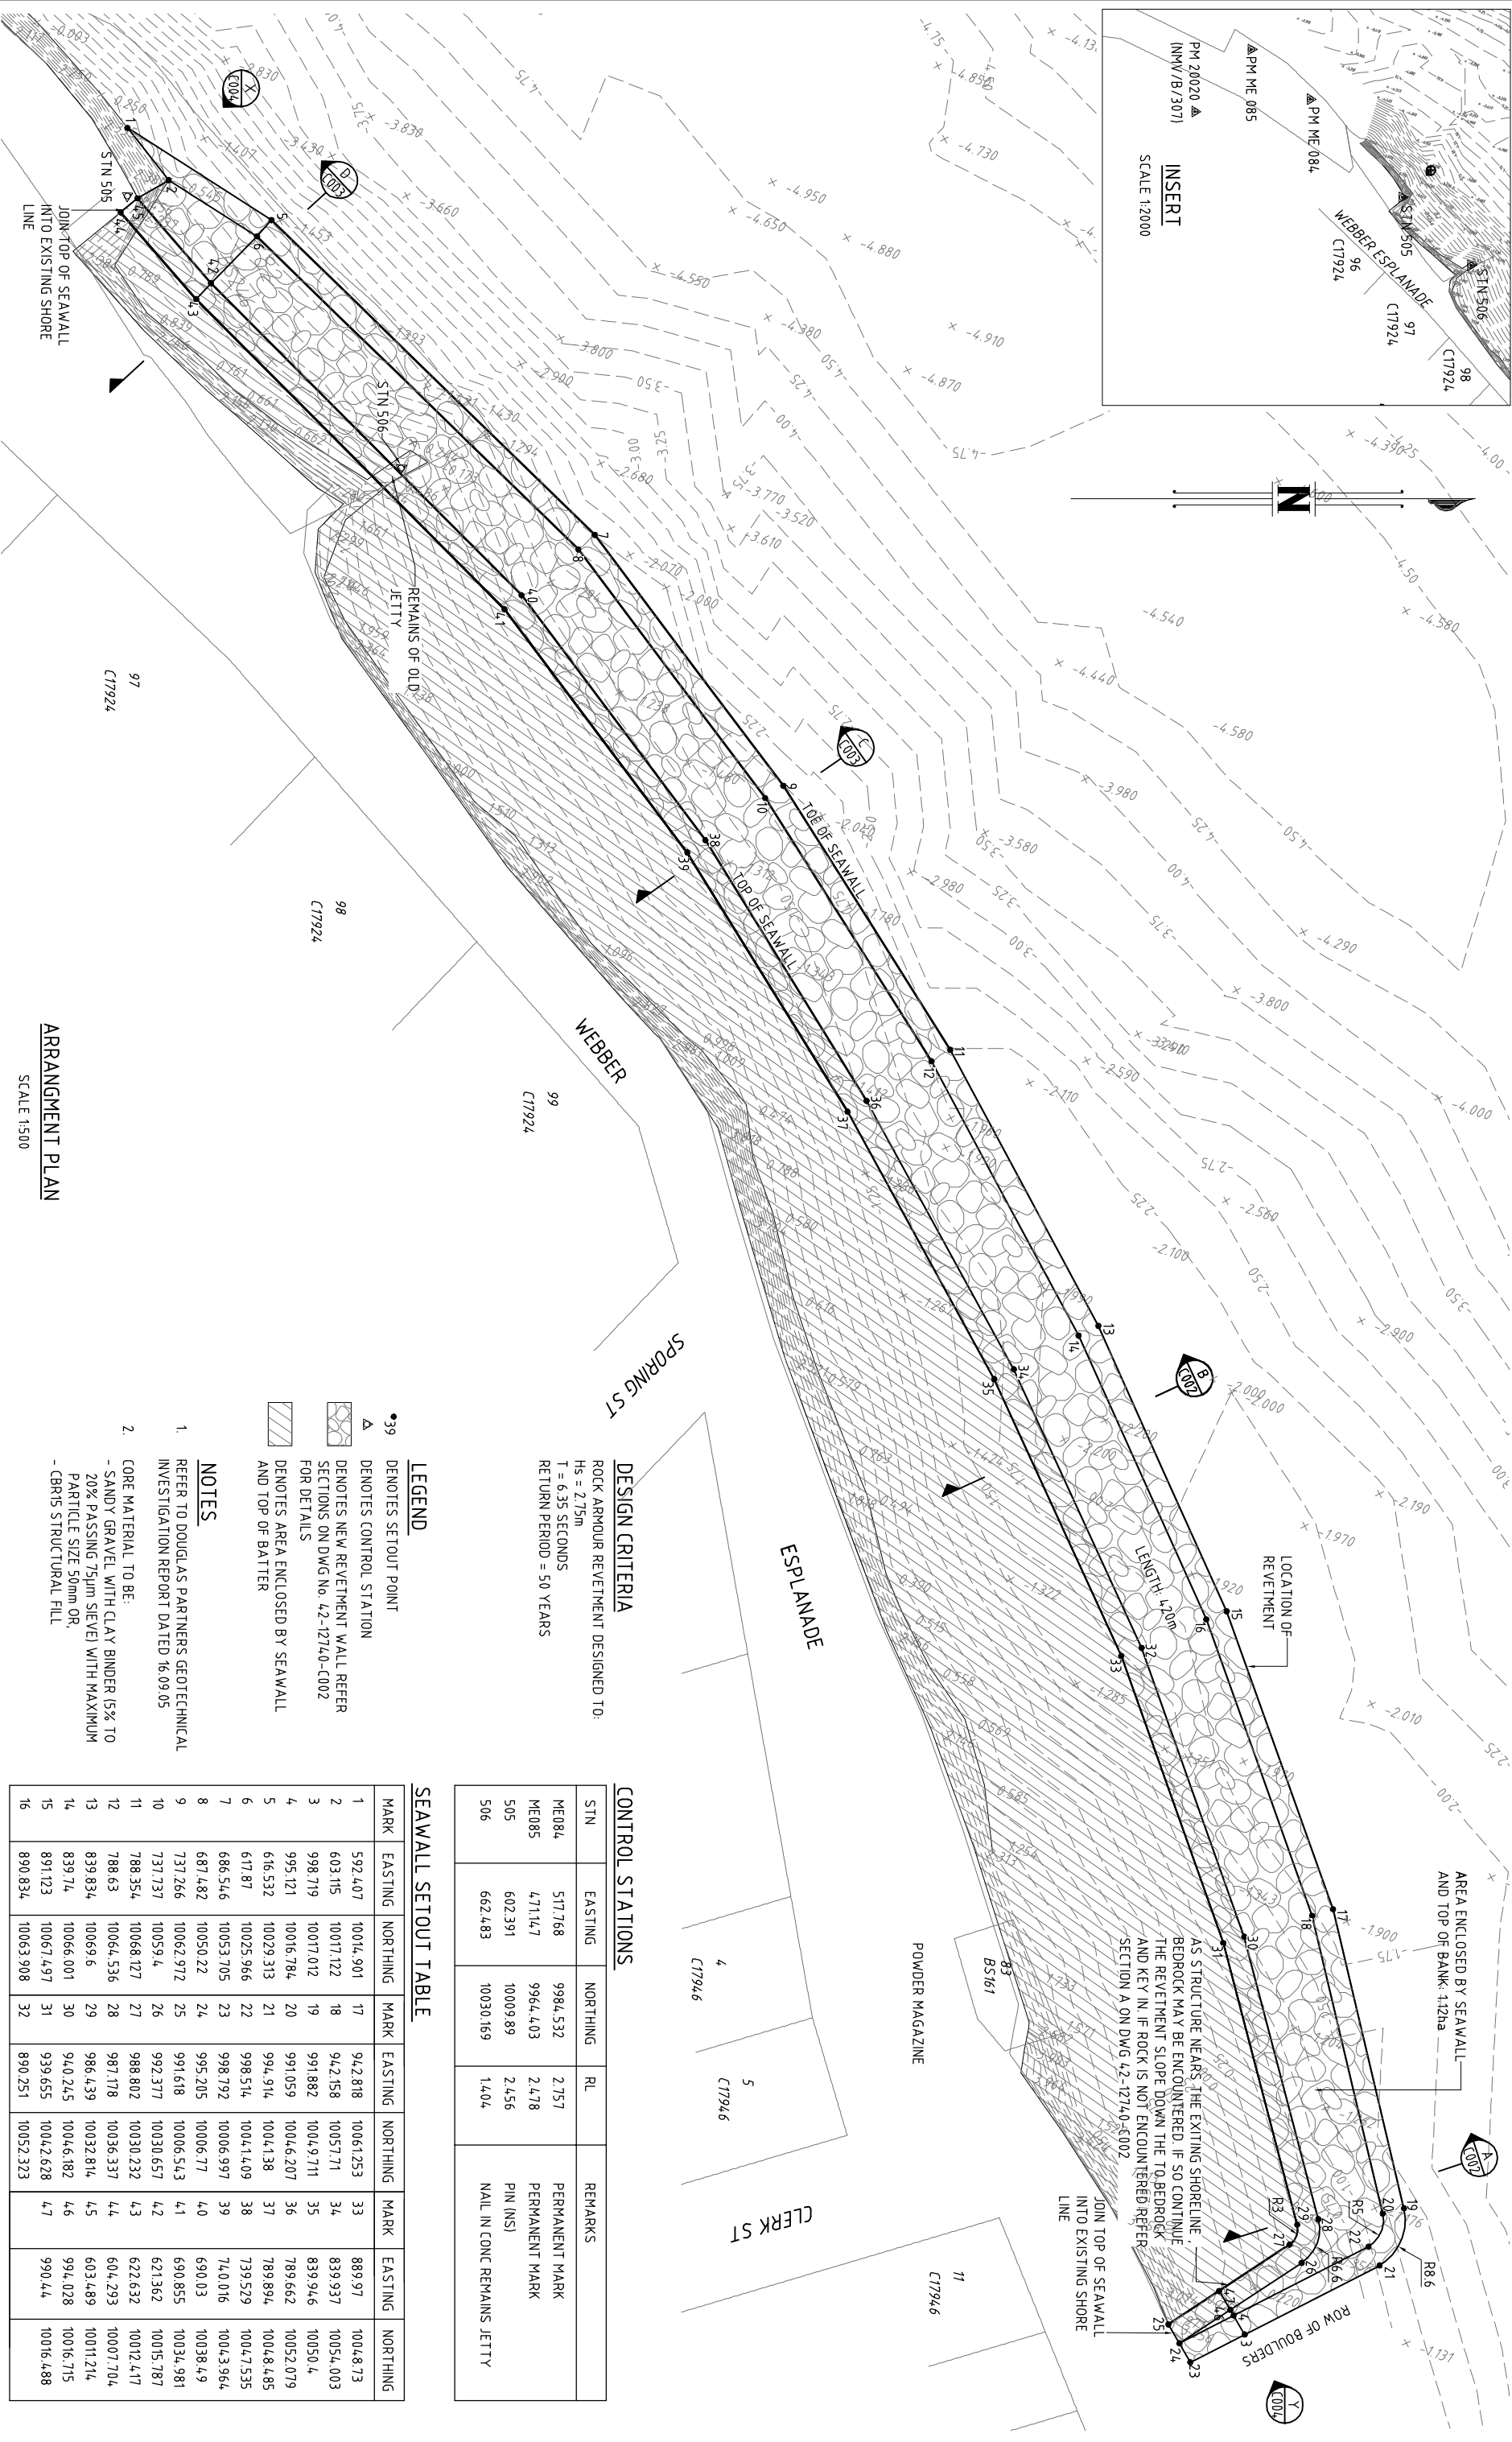
| Title | NEW REDEMPTION WALL GENERAL ARRANGEMENT PLAN |

ROCK ARMOUR REDEMPTION DESIGNED TO:
Hs = 2.75m
T = 6.35 SECONDS
RETURN PERIOD = 50 YEARS

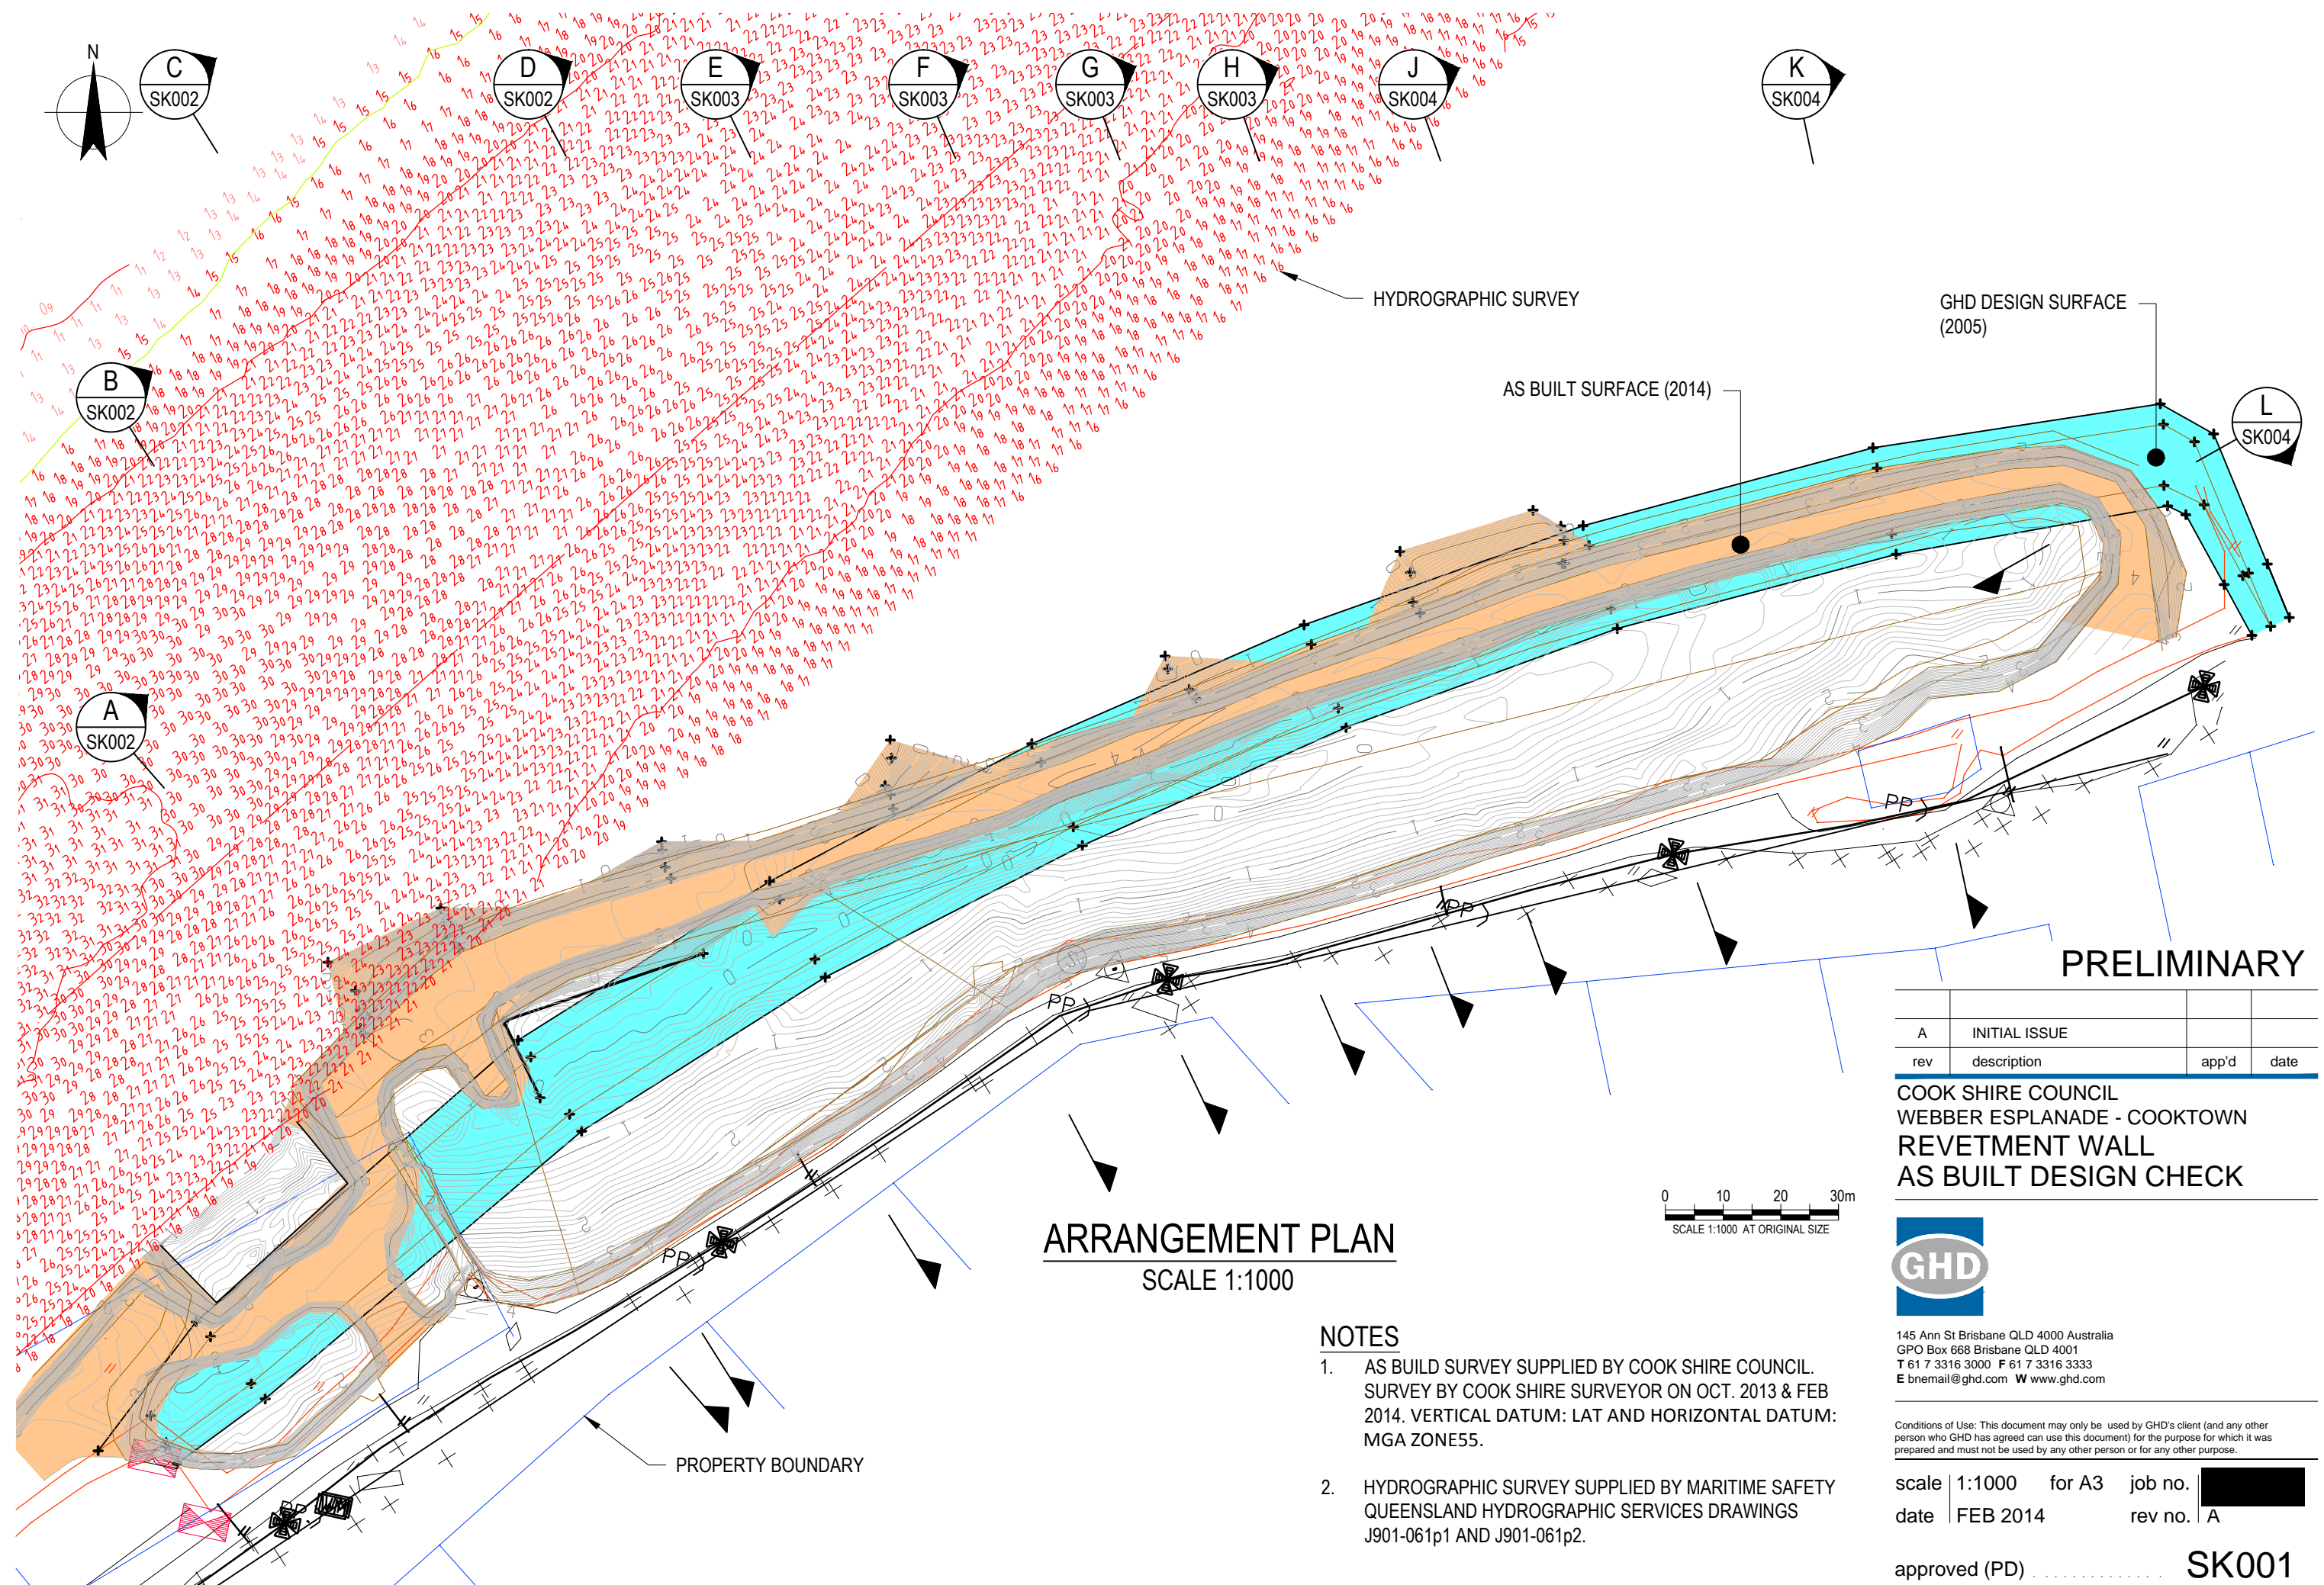
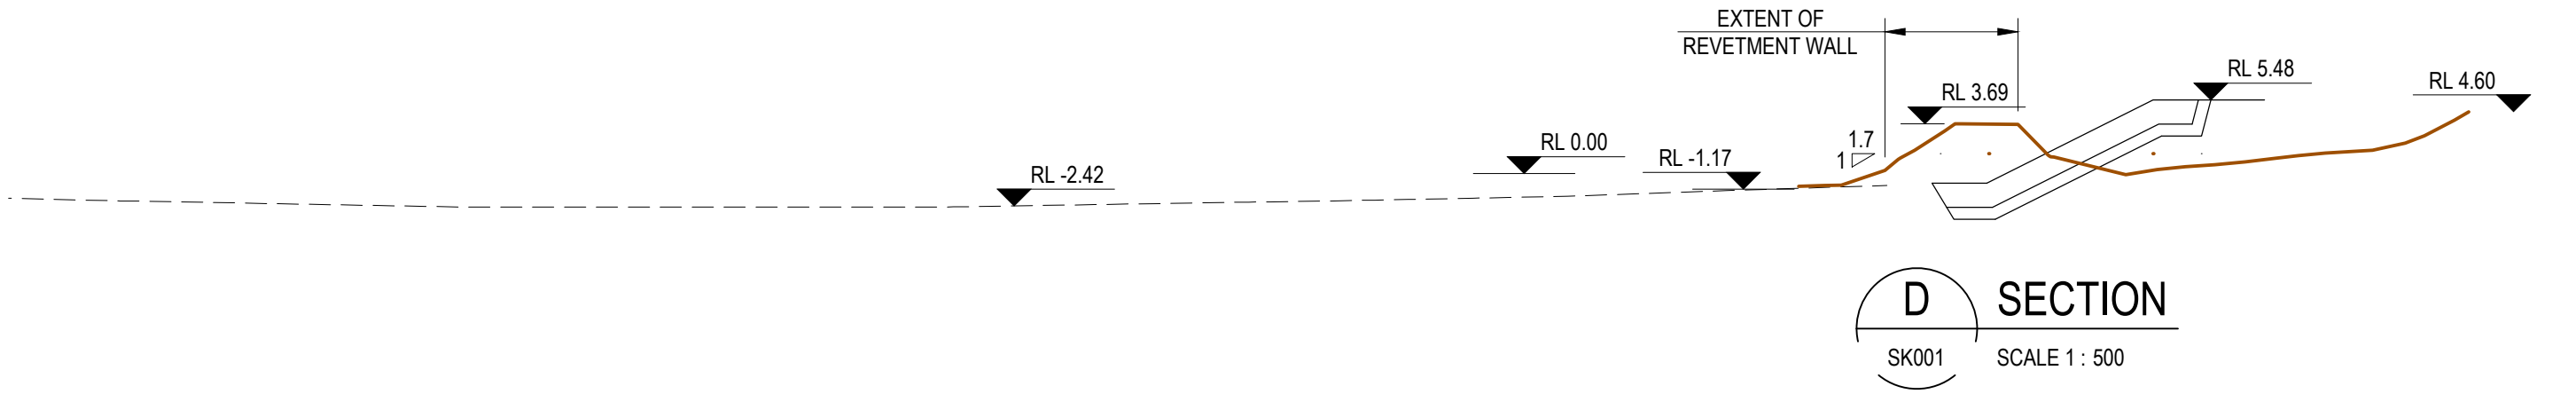
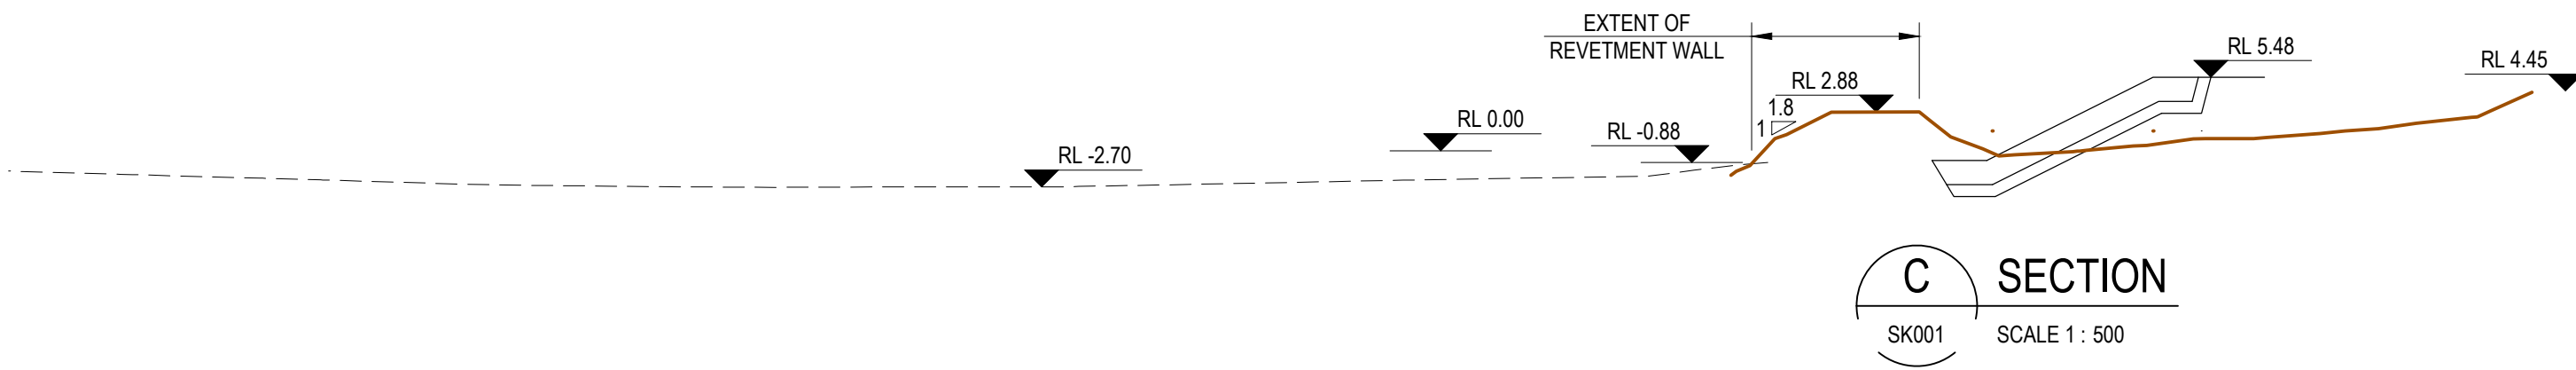
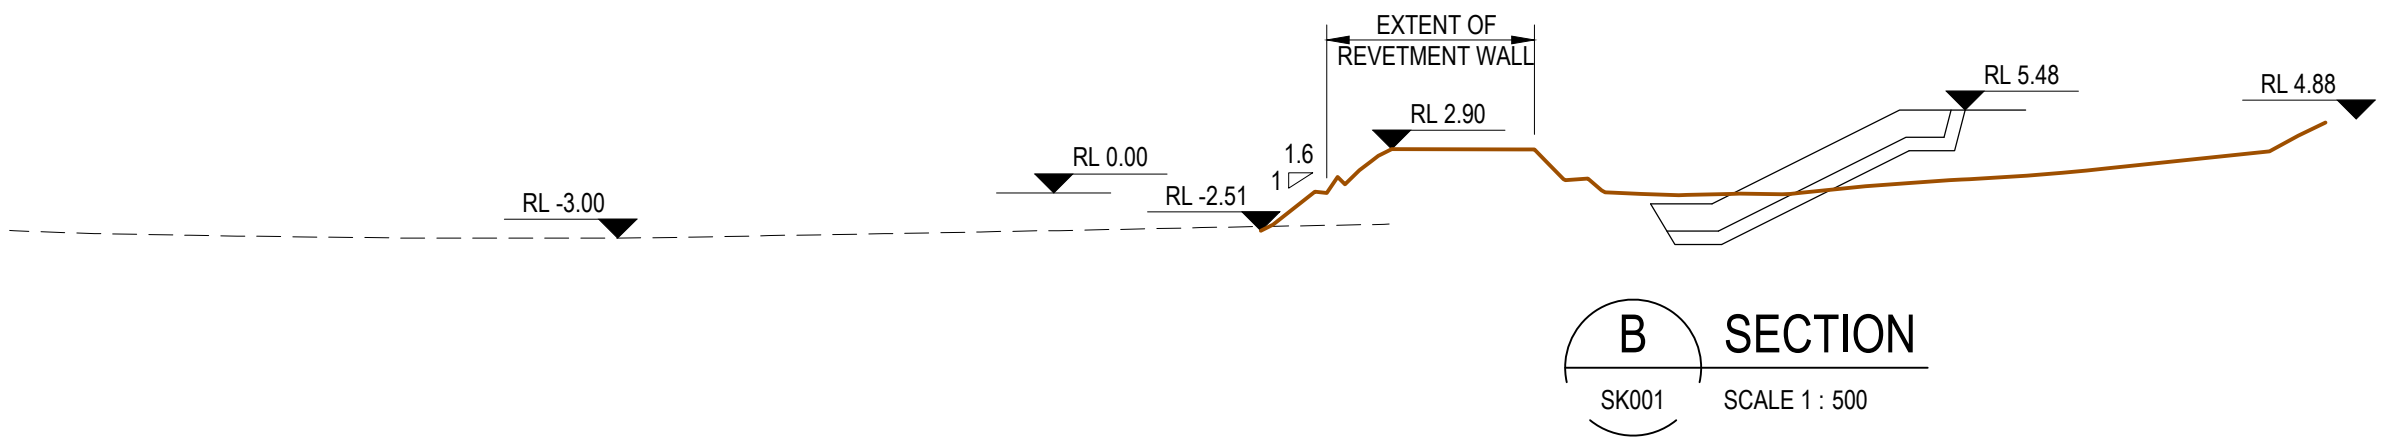
approved (PD) SK002

- c. The 'as-constructed' sketch provided in Appendix B is not consistent with the supplied 'as-constructed' survey (see SK-002 to SK-004). In particular;

- i. The two large rocks (1.5 to 1.8 m) cannot be confirmed.
 - ii. The crest of the 'as-constructed' rock revetment is substantially lower than the level of +4.237 m LAT provided in the Appendix B sketch.

The sections taken from the 'as-constructed' survey, as shown in SK-002 to SK-004 within appendix C, shows that the rock armour slope varies from 1 in 1.1 at the western end trending up to 1 in 2 at the eastern end. If the survey is a true reflection of the 'as-constructed' rock armour slope, it is recommended that additional rock is placed on the armour face in order to obtain the 1 in 2 design slope.

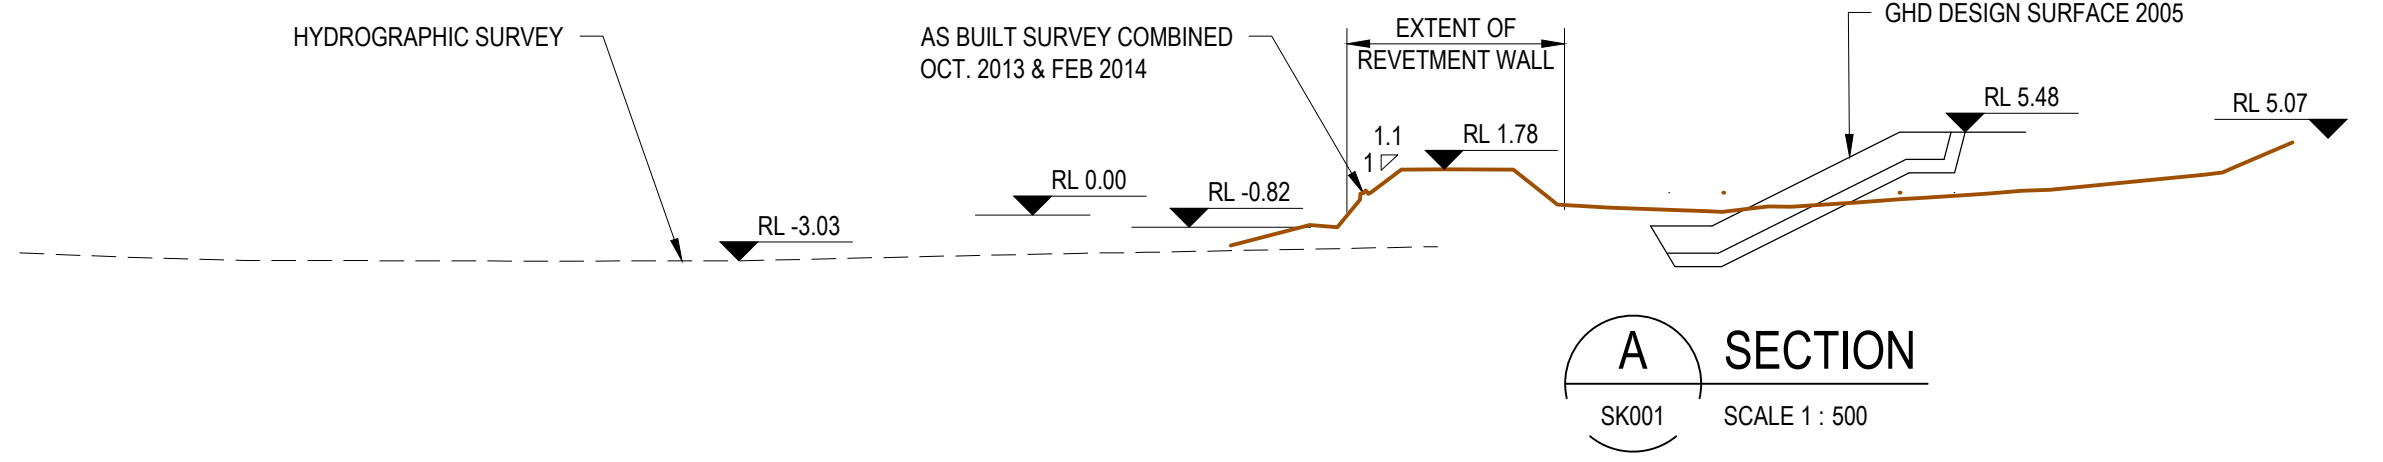
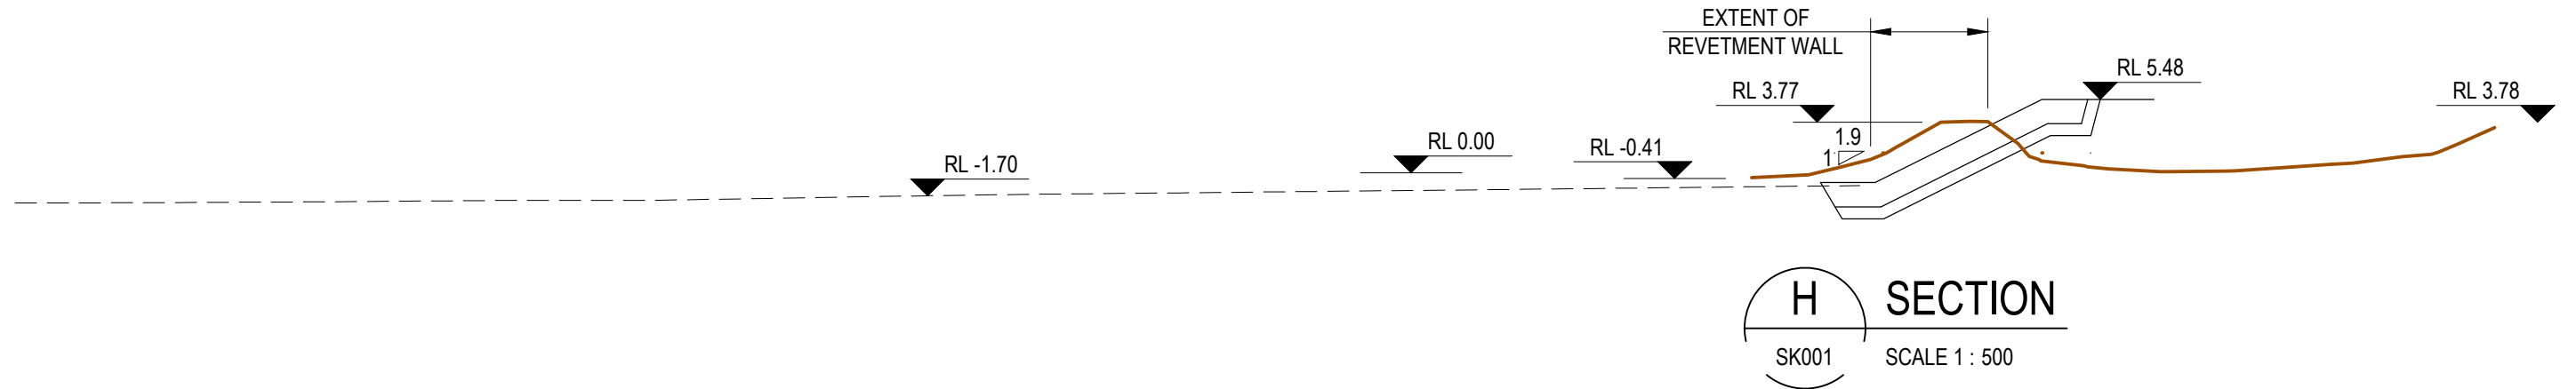
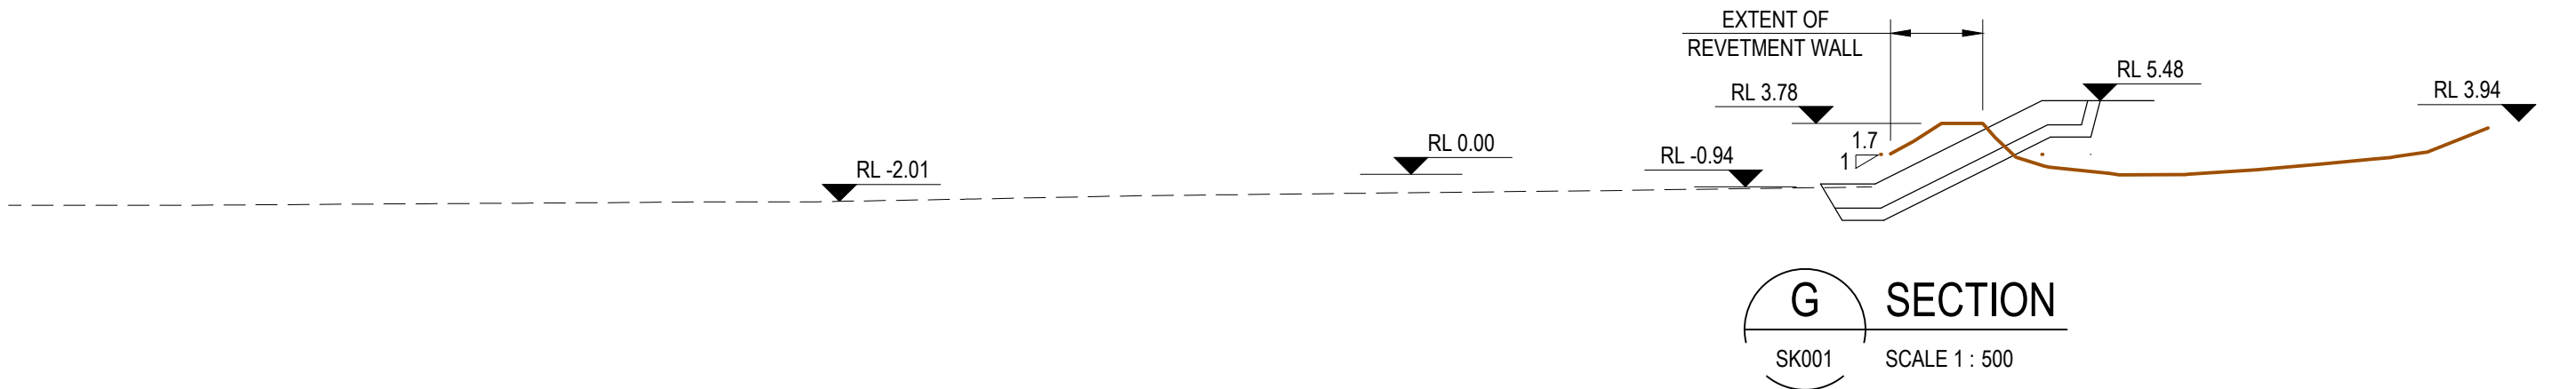
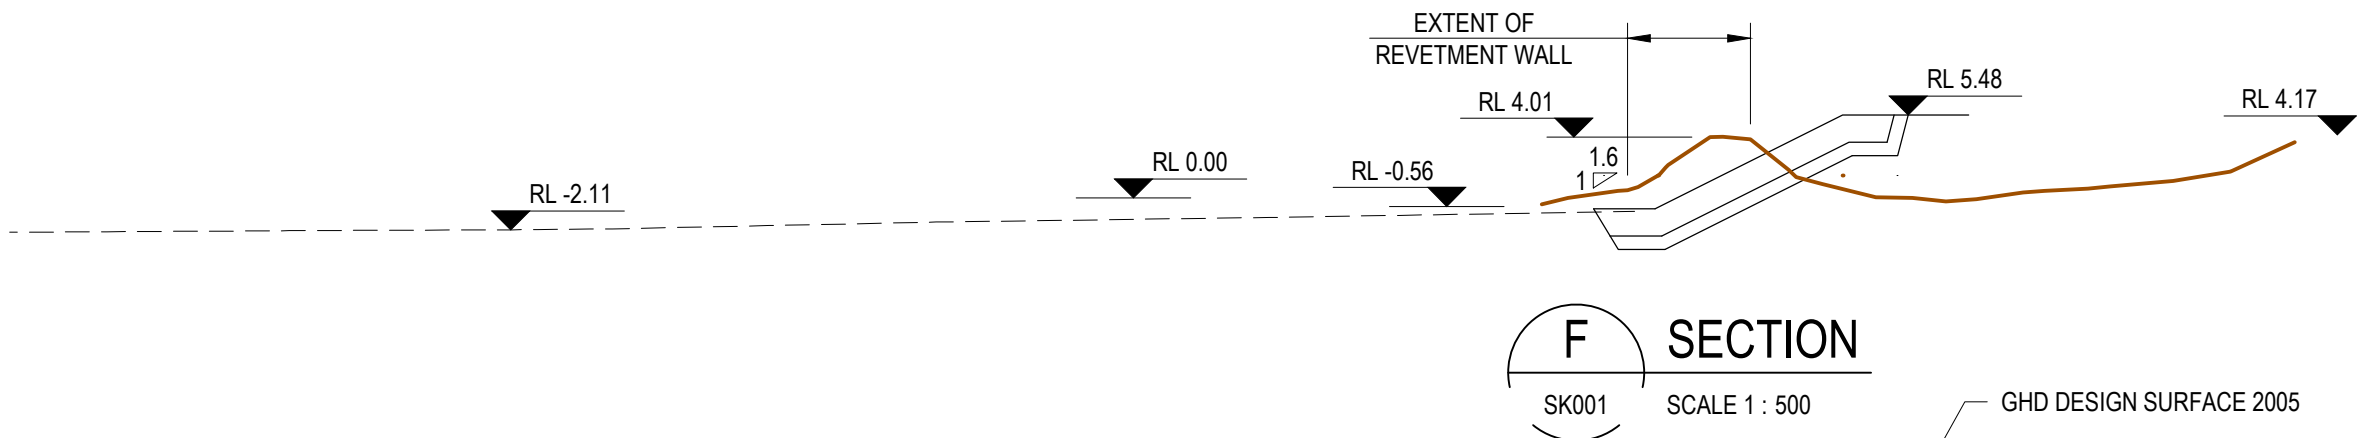
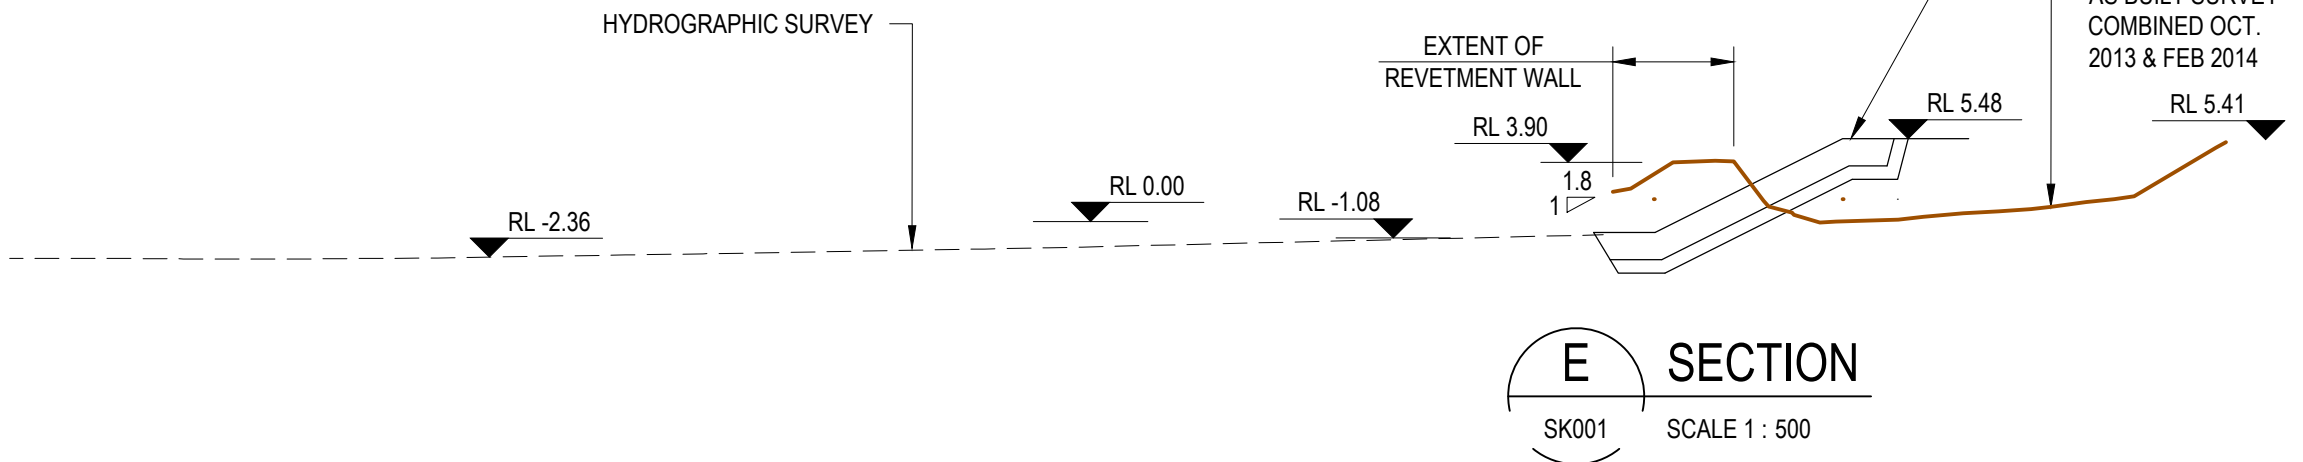
approved (PD) **SK003**

The slope stability analysis was based on cross-sections produced from topographic surveys dated Oct 2013 and Feb 2014 provided to GHD. Cross-section E (Sketch SK-003) was selected for slope stability analysis as it represents the highest part of the revetment wall and has a maximum crest-to-toe height of approximately 5 m.
