Cook Shire Council

Webber Esplanade

Rock Revetment Review

April 2016

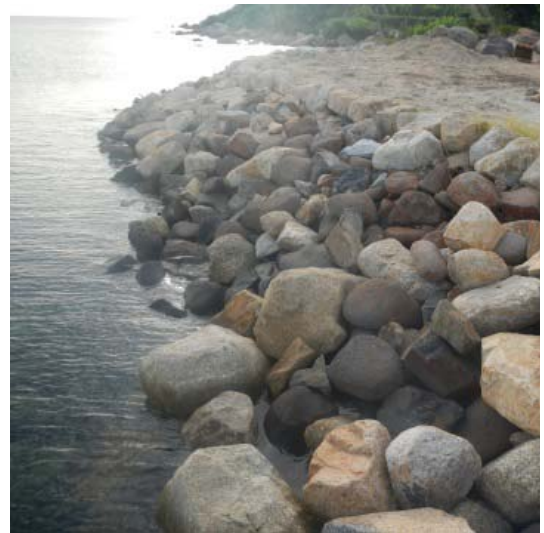
Photo 2

3.	<p>Armour porosity too high with poor interlocking evident. Some armour rock is unstable under foot. It appears likely that rock was end dumped from truck tipper as opposed to being selectively placed by excavator in 2 layers. See photos 2 and 17, below in particular.</p>	Strictly not specified	No, under sized armour rock non-compliant with design storm event criteria

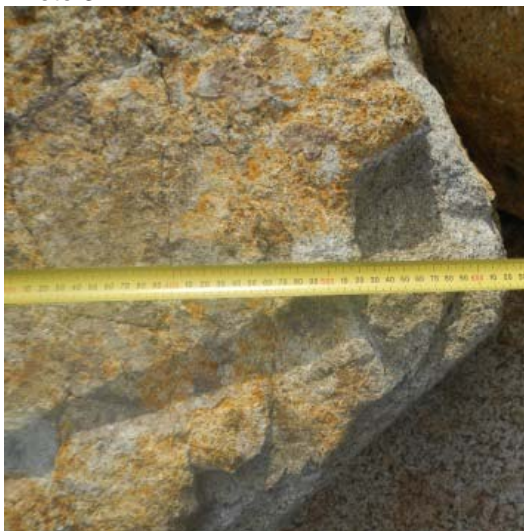
Photo 5

2.	<p>Armour rock on the slope has a wide grading, generally ranging from 30 mm (D_{min}) to 1500 mm (D_{max}). See photos 4 to 7, 11 to 14 and 21 to 28 below, in particular.</p>	No	No, under sized armour rock non-compliant with design storm event criteria

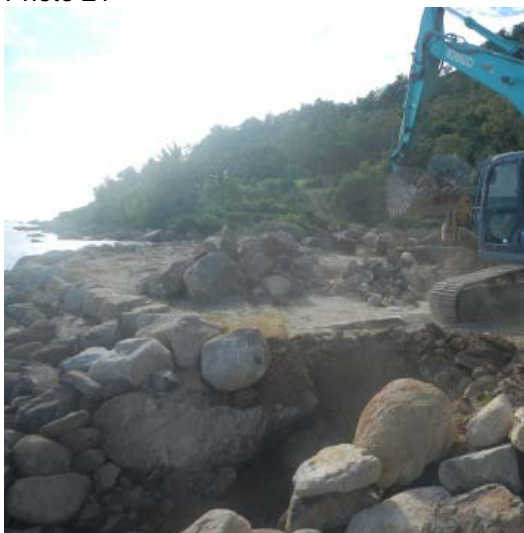
Photo 23

4.	<p>Underlayer rock has too wide a grading, with a high fraction of small rock. It appears likely that rock was end dumped from truck tipper as opposed to being selectively placed by excavator in 2 layers. See photos 21 to 28 below, in particular.</p>	No	No, under sized underlayer rock non-compliant with design storm event criteria

5.	<p>Core material consists of sand and gravel material. Based on the core material removed, it is conservatively estimated that the fine sand material fraction exceeds 50% passing. See photos 21 to 28 below, in particular.</p>	No	No, fine material non-compliant with design storm event criteria

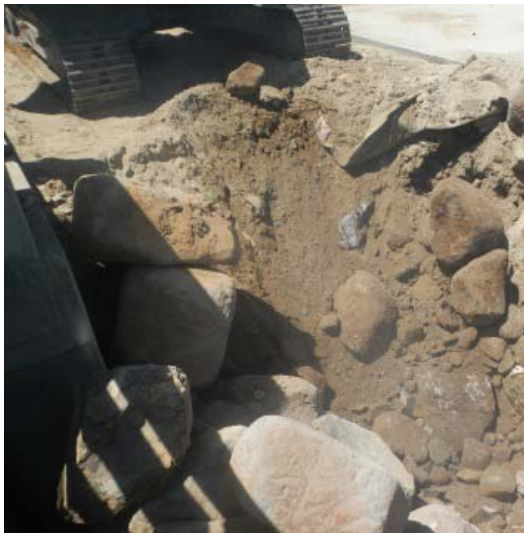
Photo 47

2.	<p>Armour rock on the slope has a wide grading, generally ranging from 30 mm (D_{min}) to 2000 mm (D_{max}). Two distinct layers of rock armour not placed. See photos 47 to 50 below, in particular.</p>	No	No, under sized armour rock non-compliant with design storm event criteria

4.	<p>Underlayer rock has too wide a grading, with a high fraction of small rock. It is likely that rock was end dumped from truck tipper as opposed to being selectively placed by excavator in 2 layers. See photos 47 to 50 below, in particular.</p>	No	No, under sized underlayer rock non-compliant with design storm event criteria

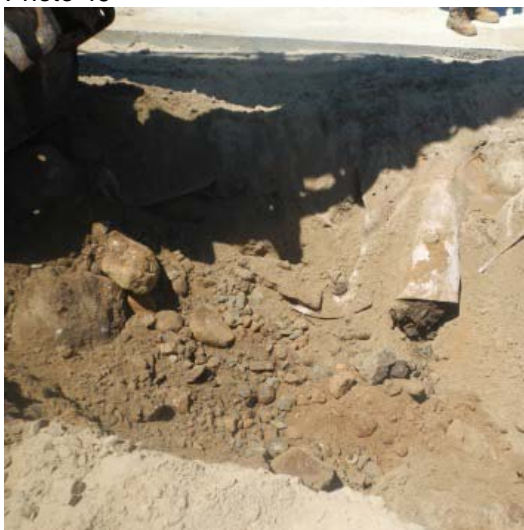
Photo 51

5.	<p>Core material consists of sand and gravel material. Based on the core material removed, it is conservatively estimated that the fine sand material fraction exceeds 50% passing. See photos 49 to 53 and 57 below, in particular.</p>	No	No, fine material non-compliant with design storm event criteria

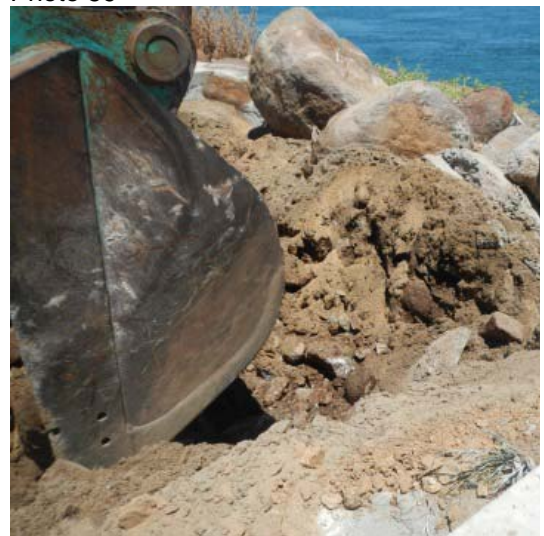
Photo 60

2.	Armour rock on the slope has a wide grading, generally ranging from 30 mm (D_{min}) to 1500 mm (D_{max}). See photo 60 in particular.	No	No, under sized armour rock non-compliant with design storm event criteria

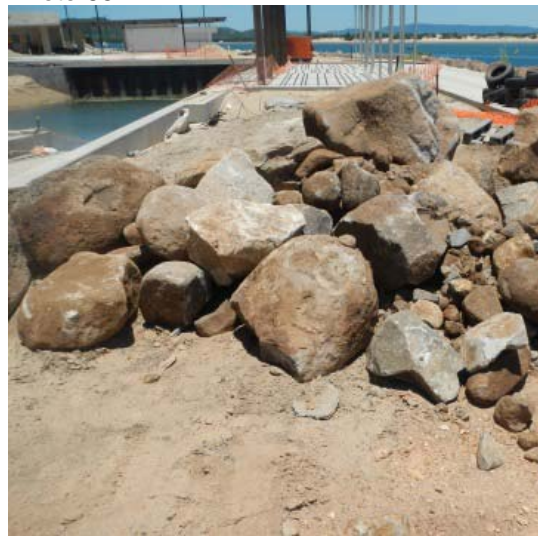
Photo 66

5.	Core material consists of sand and gravel material. Based on the core material removed, it is conservatively estimated that the fine sand material fraction exceeds 50% passing. See photo 66 in particular.	No	No, fine material non-compliant with design storm event criteria

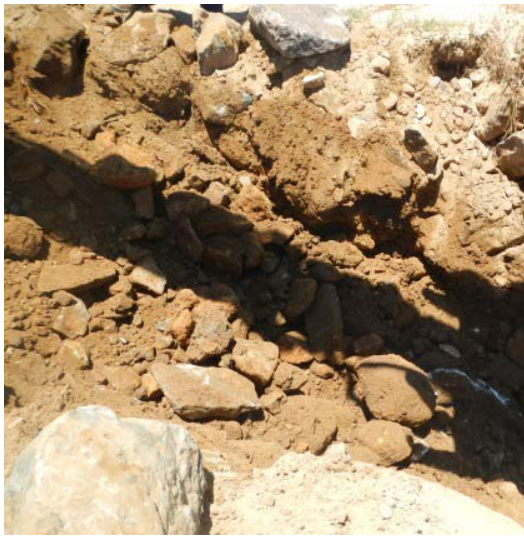
Photo 70

4.	Underlayer rock has too wide a grading, with a high small rock fraction. It appears likely that rock was end dumped from truck tipper as opposed to being selectively placed by excavator in 2 layers. See photos 70 and 71 below, in particular.	No	No, under sized underlayer rock non-compliant with design storm event criteria

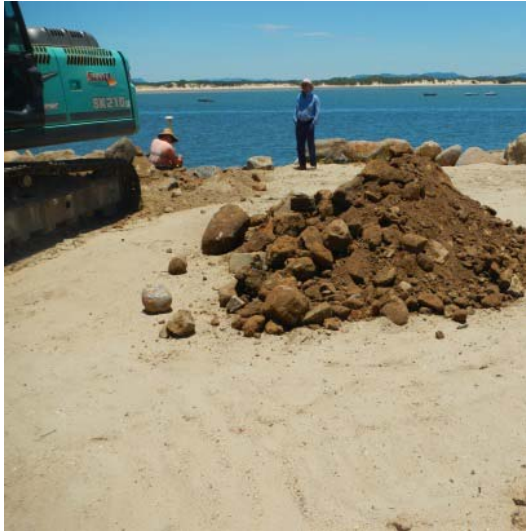
Photo 74

5.	Core material consists of sand and gravel material. Based on the core material removed, it is conservatively estimated that the fine sand material fraction exceeds 50% passing. See photo 74 below, in particular.	No	No, fine material non-compliant with design storm event criteria

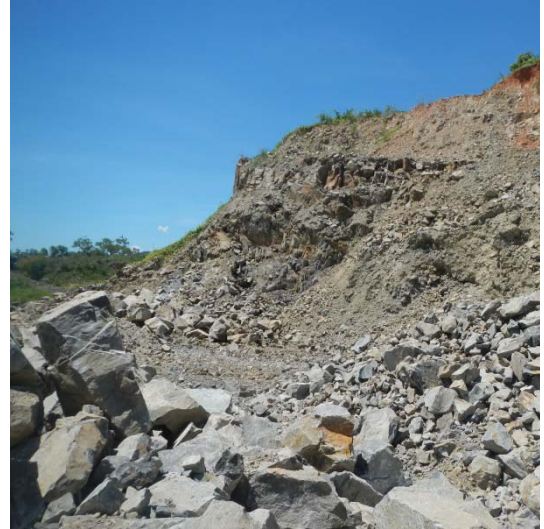
Photo 84

A visit to the local Mt Amos quarry was undertaken on the 18 February 2016 to inspect and assess the feasibility of sourcing additional rock for any remedial works. It is understood that further removal of overburden and blasting of the current rock face, as shown in photo 84, is feasible.
