**Cook Shire**  
**COUNCIL**

**Coen**

# **Drinking Water Quality Management Plan**

Coen Site Based DWQMP

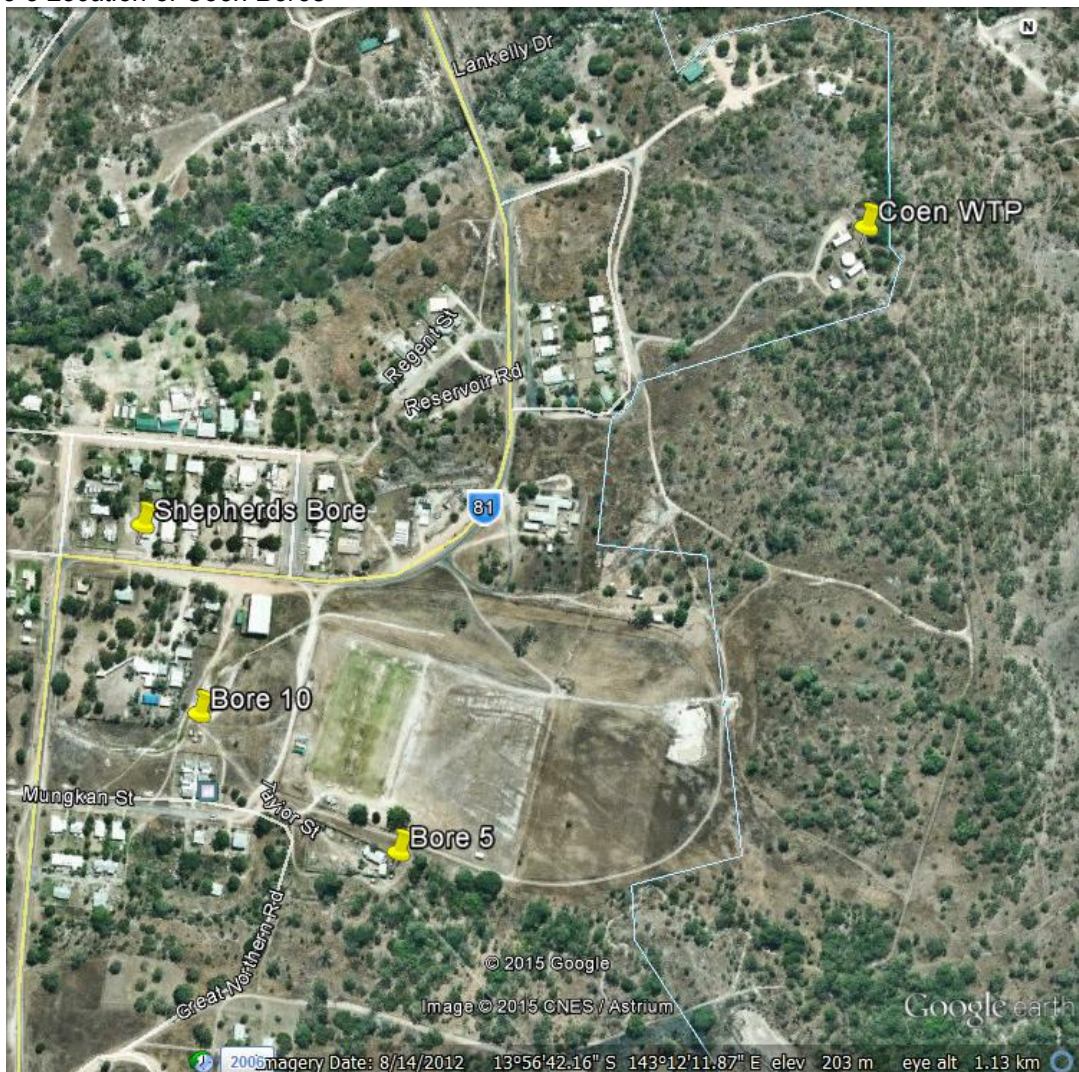
Figure 5 Location of Coen Bores

The Coen bores are used to provide water to the town when the Lankelly Creek and Coen Dam turbidity is high after a rain event in the wet season. Bores 5 and 10 have yields of ~2L/s and Shepherd's Bore has a yield of ~1 L/s. The bores are unable to provide the full supply during the dry season.

Bores 5 and 10 are recharged with treated water when the Lankelly Creek supply is used, and records maintained of the volume recharged.

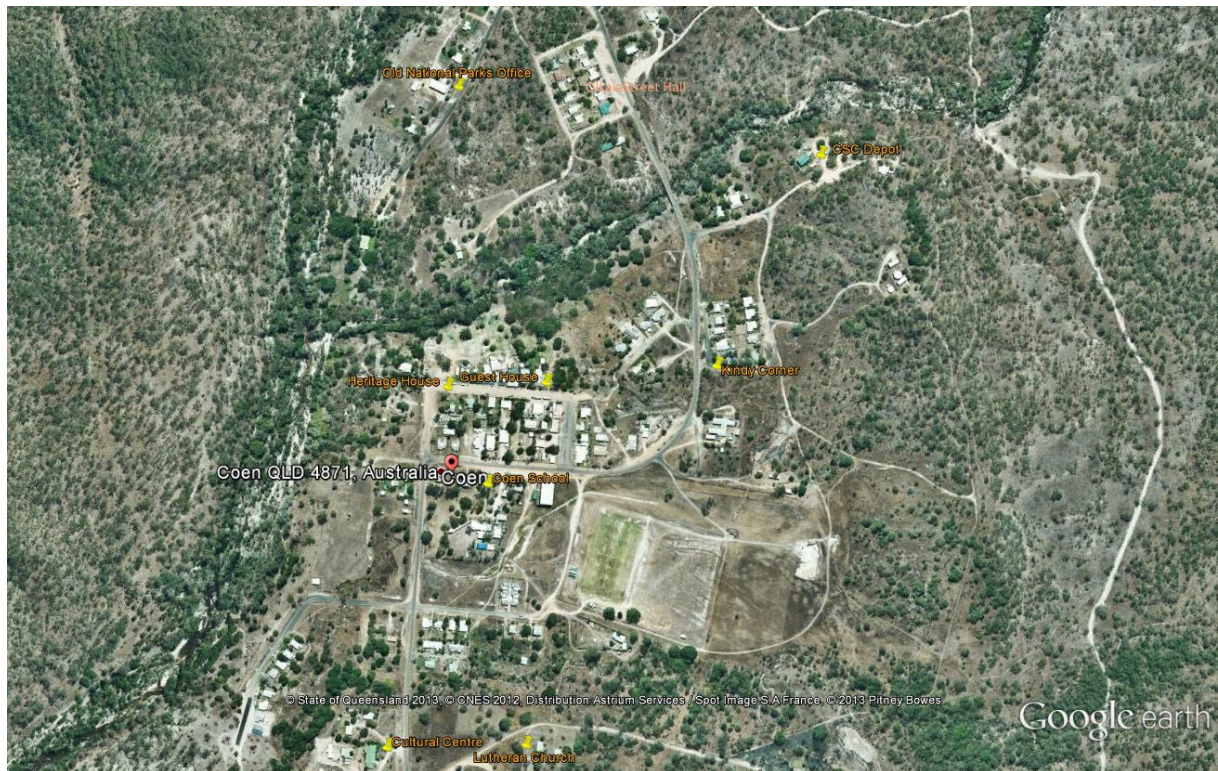
Figure 10 Reticulation sampling locations

The above sample locations give a good cross section of the town including the dead end areas as shown in the figure below.
