## Drinking Water Quality Management Plan

Laura Site Based DWQMP

Cook Shire Council

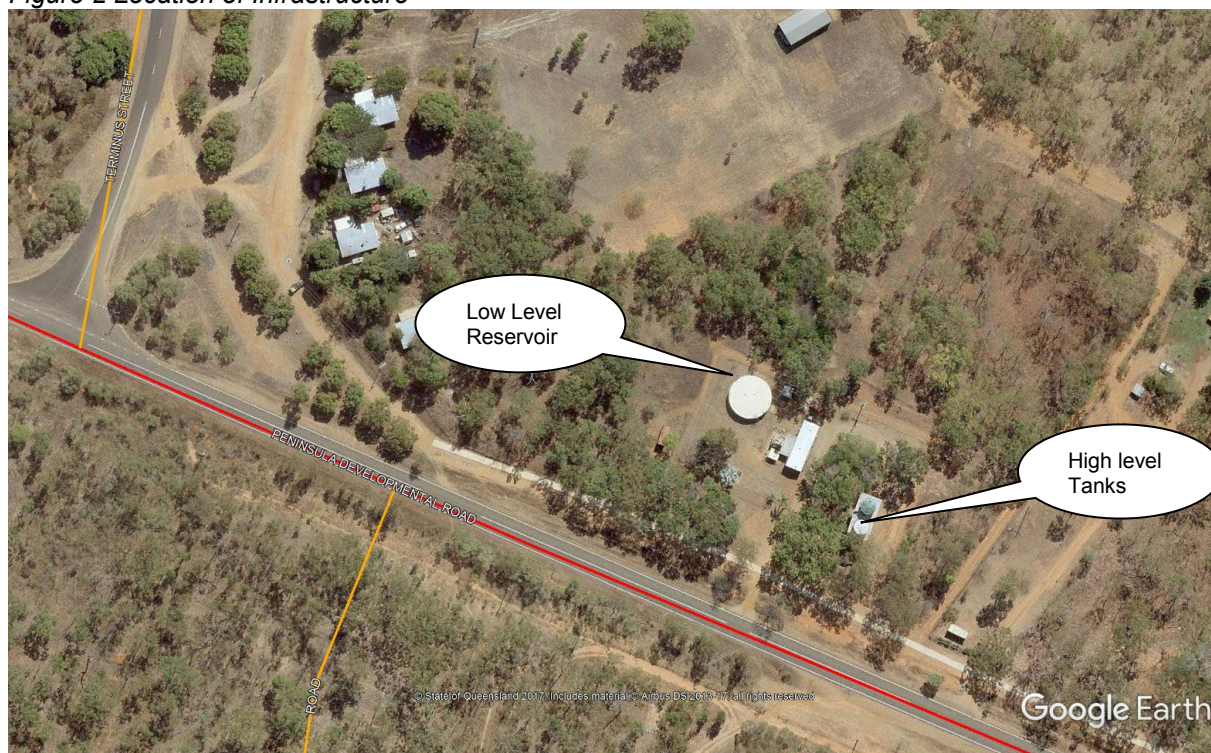
Figure 2 Location of Infrastructure

Bore 1 was drilled in 1996 to a depth of 150 m, through the Gilbert River and Dalrymple Sandstone. Bore 1 has a plastic casing, is grouted to a depth of 28 m, and taps aquifers at 70-76 and 118 to 148m depth. Water quality of the bore is very good with the exception of high levels of dissolved iron that require treatment.

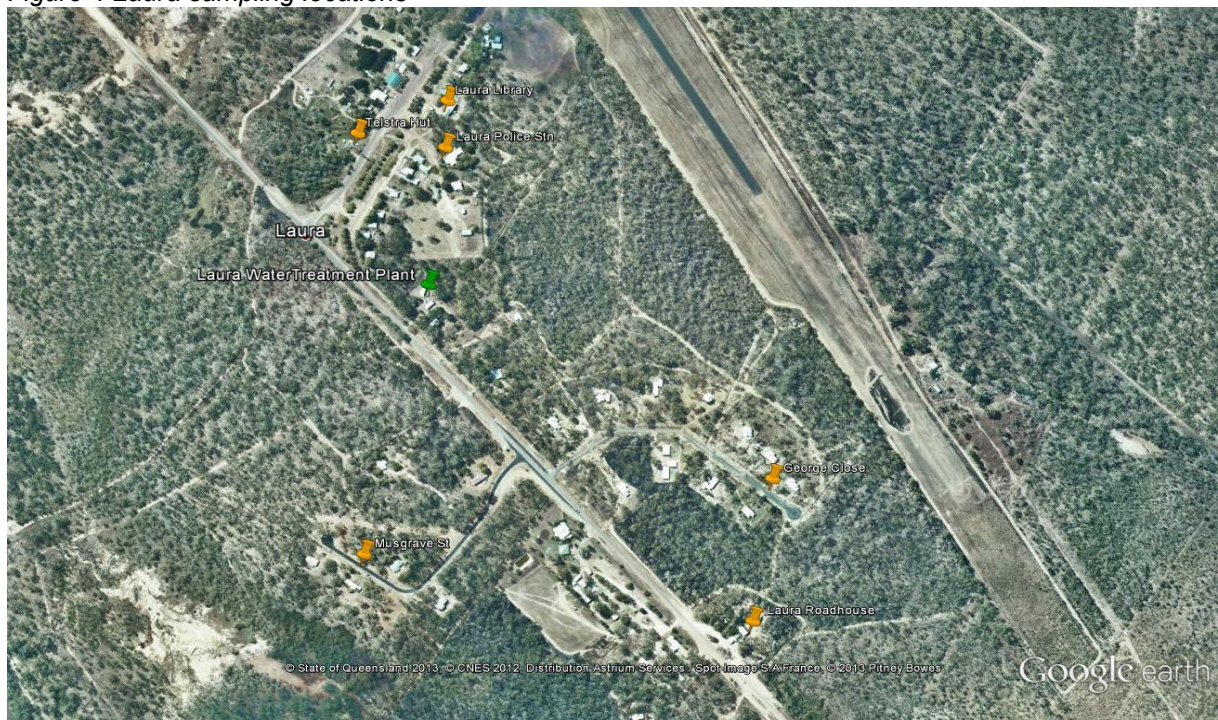
Figure 4 Laura sampling locations

Sample Location Name	Street Name	Site Chosen Because	GPS Coordinates *
Laura Roadhouse	Peninsula Development Rd	End of the line.	15°33'59.10"S - 144°27'3.32"E
Telstra Hut	Terminus St	Towards the end of the line.	15°33'32.89"S - 144°26'42.73"E
Laura Library	Terminus St	Ease of access	15°33'31.15"S - 144°26'47.43"E
Laura Police Stn	Gladwell Court	Centrally located	15°33'33.67"S - 144°26'47.32"E
End of George Close	George Close	Towards the end of the line.	15°33'51.48"S - 144°27'4.35"E
End of Musgrave St	Musgrave St	Towards the end of the line.	15°33'55.55"S - 144°26'43.10"E

The above sample locations give a good cross section of the town including the dead end areas as shown in the figure below.
