**Cook Shire**  
**COUNCIL**

Coen

Drinking Water Quality Management Plan

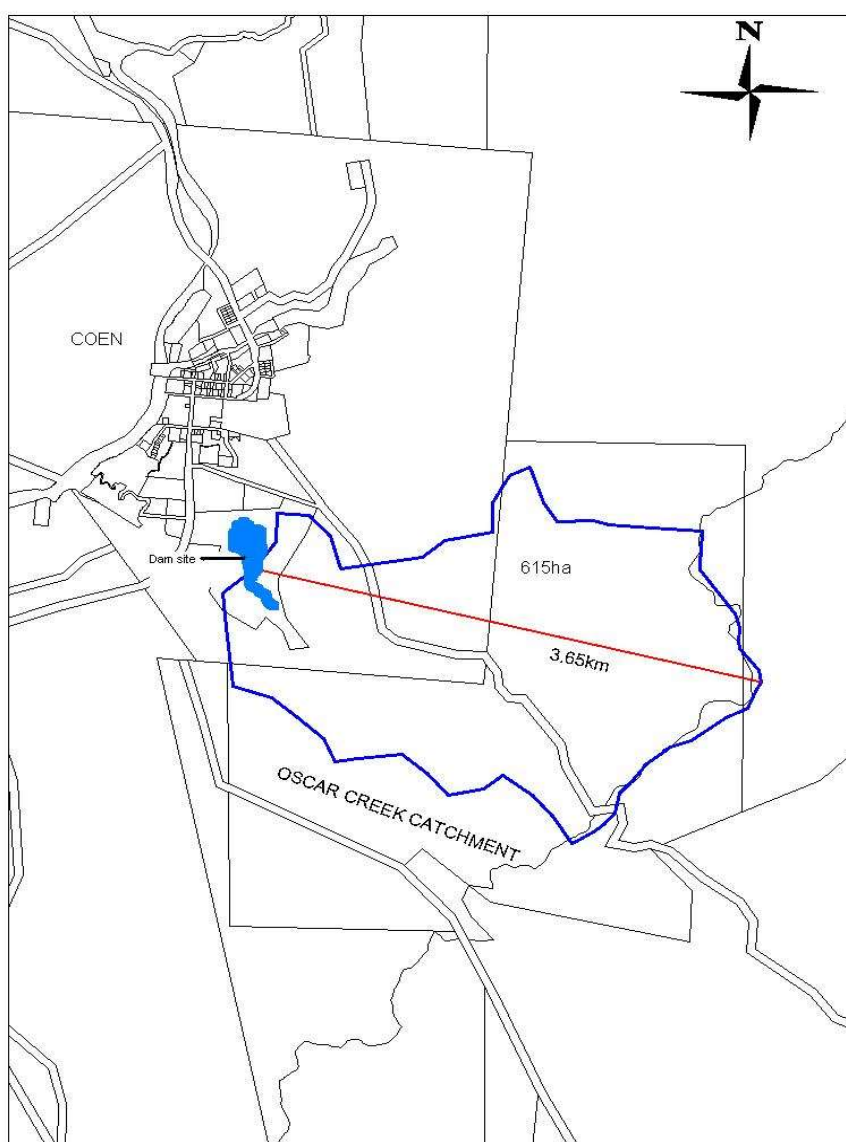
Figure 4 Coen Dam Catchment

The Coen Dam is located ~1.5 km South of Coen on the Oscar Creek. The dam was originally built for a gold mine, but was purchased by Council in the 1990s to ensure that Coen had sufficient water supply. The dam capacity is unknown. The dam fills annually, and the water quality is good, as can be seen in the Google Earth image (Figure 2), the dam has significant amounts of lilies but this is not an issue and coverage has not increased for numerous years. The dam can be subject to blooms of cyanobacteria, but not annually and treated with algacide if required. The dam catchment also originates in the McIlwraith Range in KULLA national parks.

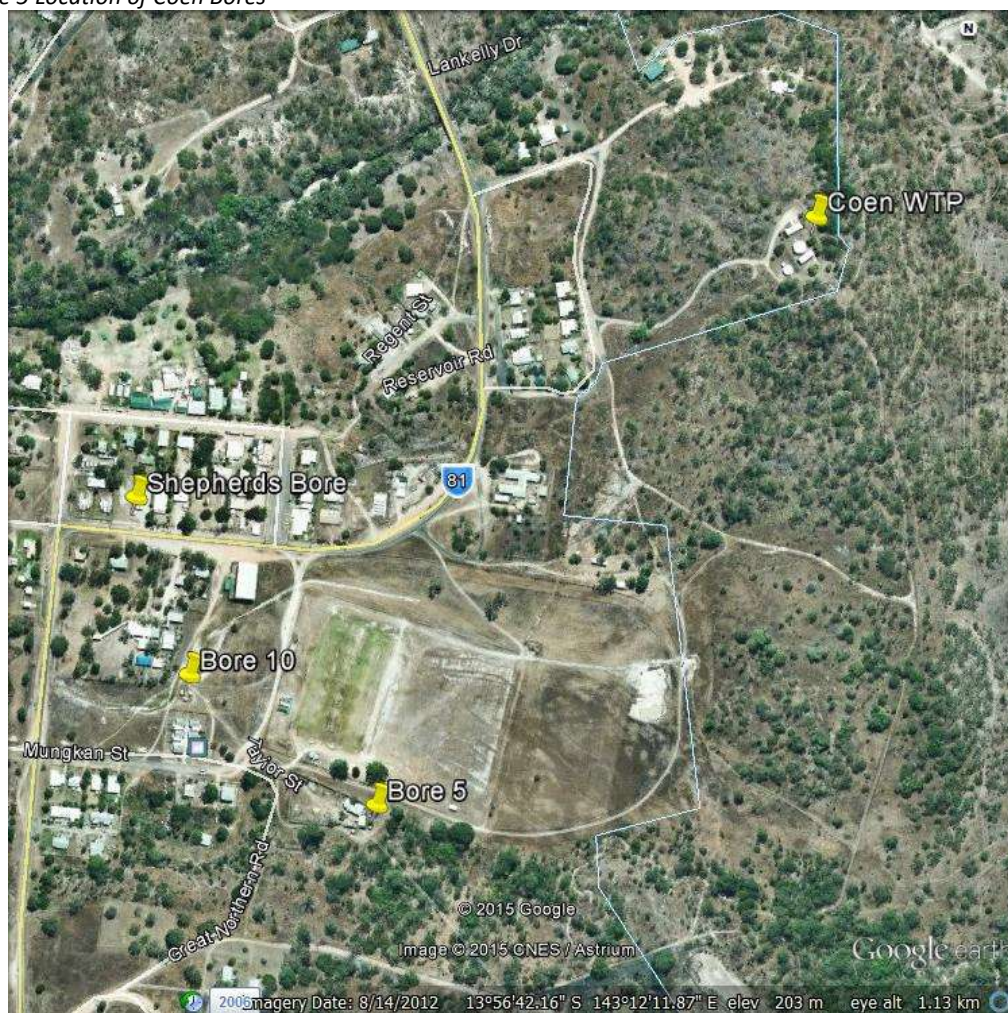
Figure 5 Location of Coen Bores

The Coen bores provide water to the town when the Lankelly Creek and Coen Dam turbidity is high after a rain event in the wet season. Bores 5 and 10 have yields of ~2L/s and Shepherd's Bore has a yield of ~1 L/s. The bores are unable to provide the full supply during the dry season.

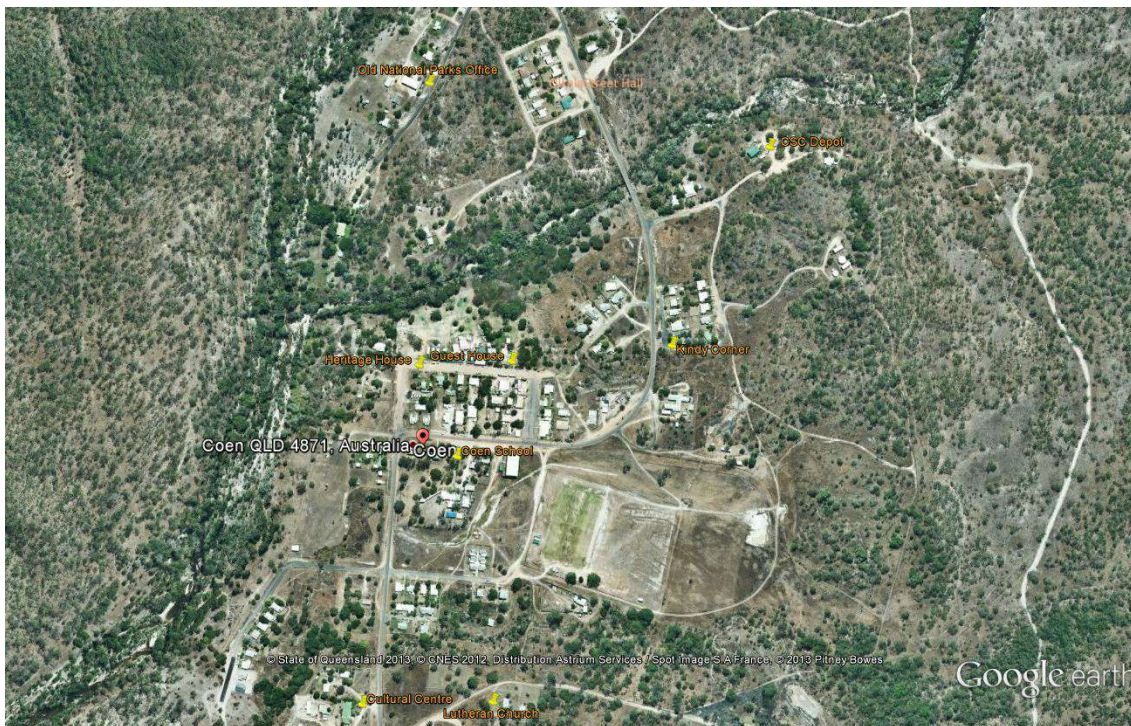
Figure 10 Reticulation sampling locations

The above sample locations give a good cross section of the town including the dead end areas as shown in the figure below.
